## CUP 2 HydroFLOW Water Conditioning System Program Analysis

Kaiser Permanente Vallejo Medical Center  
Vallejo, CA

Analysis Period: July 2016 - July 2017

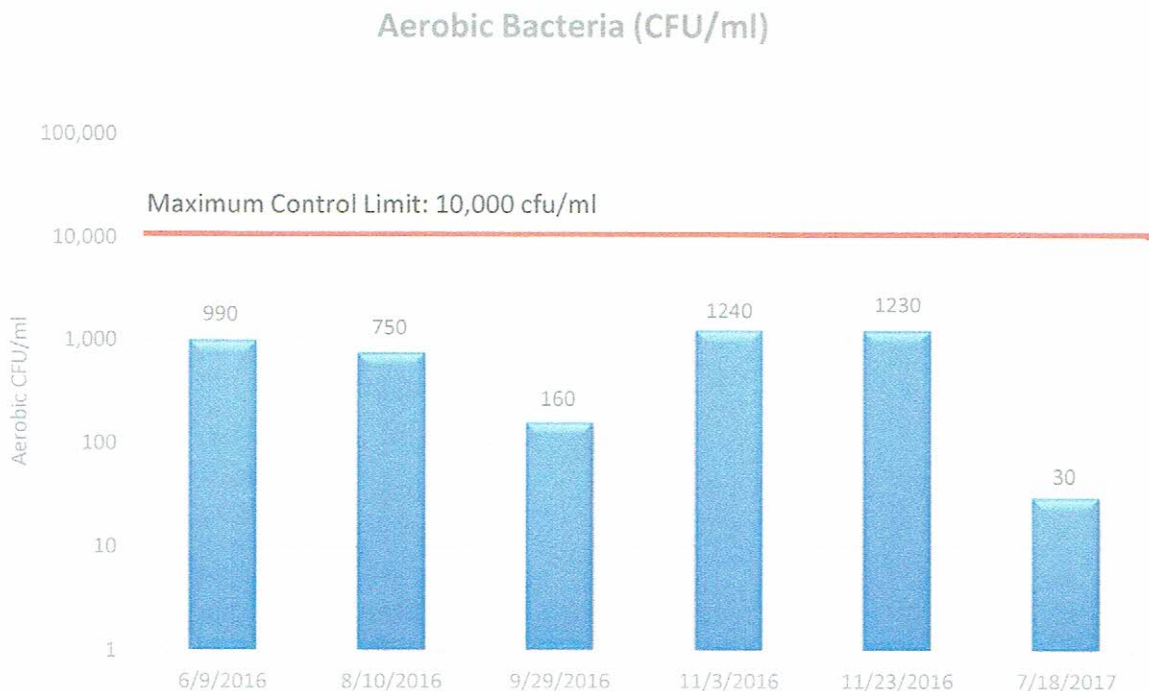
### **Condenser Water Aerobic Bacteria Results by Date (Goal is <10,000 cfu/ml)**

As shown below, aerobic bacteria levels in the condenser water were considered acceptable for all sampling done during this study, including the baseline sample collected prior to the changes in water treatment. The anaerobic bacteria levels were also acceptable before and during the implementation of the HydroFLOW system.

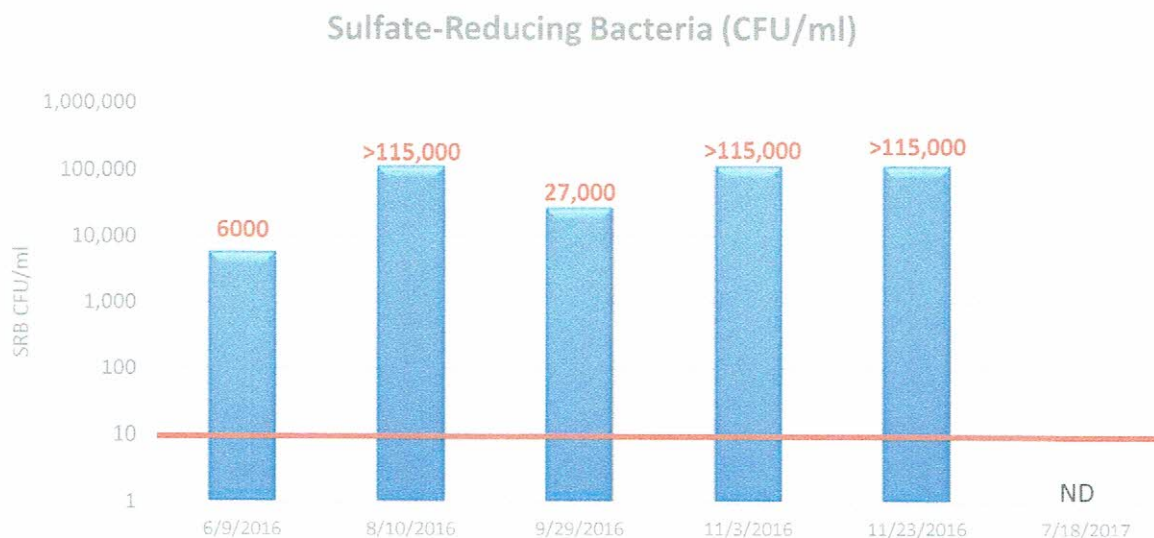
## Condenser Water Sulfate-Reducing Bacteria by Date

The results below show that condenser water has tested for unacceptable levels of sulfate reducing bacteria on all but one date sampled.

There has been a high level of Sulfate-Reducing Bacteria in the condenser water system. Sulfate-Reducing Bacteria (SRB) are typically found under deposits or foulants that collect on metal surfaces, or in areas where there is low flow (such as offline chiller tubes). These bacteria can create very corrosive condition because the anaerobic environment in which they live produces hydrogen sulfide and ferrous sulfide, which together form a malodorous (smelly) black slime. Under this slime, aggressive under-deposit corrosion will occur that can cause metallurgical failures.

Based on the first 6 months of the analysis, it appears that the HydroFLOW did NOT destroy neither Sulfate-Reducing or Iron-Reducing Bacteria. Further analysis should be conducted to monitor these levels to ensure that their presence does not lead to microbial Induced corrosion cells throughout the low flow areas of the condenser water system (cooling tower basins, offline chillers, offline recirculation pumps).

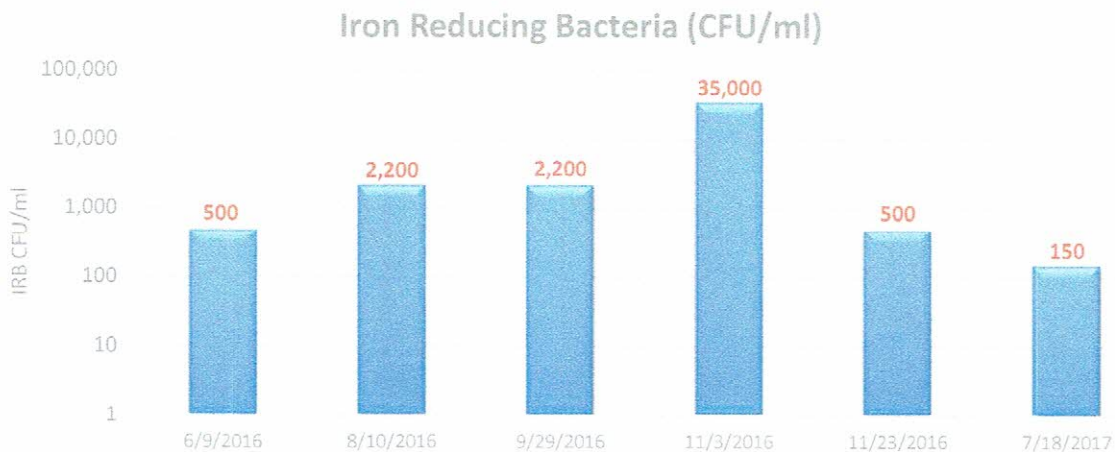
#### Condenser Water Iron Reducing Bacteria by Date

The results below show that condenser water showed acceptable levels of iron reducing bacteria after the November 3<sup>rd</sup> sampling date.

Iron-Reducing Bacteria were also found at high levels while analyzed during the HydroFLOW trial. While Iron-Reducing bacteria have been associated with microbial induced corrosion (MIC) in some research, other studies have shown that IRBs can actually inhibit corrosion of mild steel surfaces in certain cases. Sulfate-reducing bacteria are typically the more aggressive of these two types of bacteria that can cause MIC.
