Building Survey

Ref: V-0000

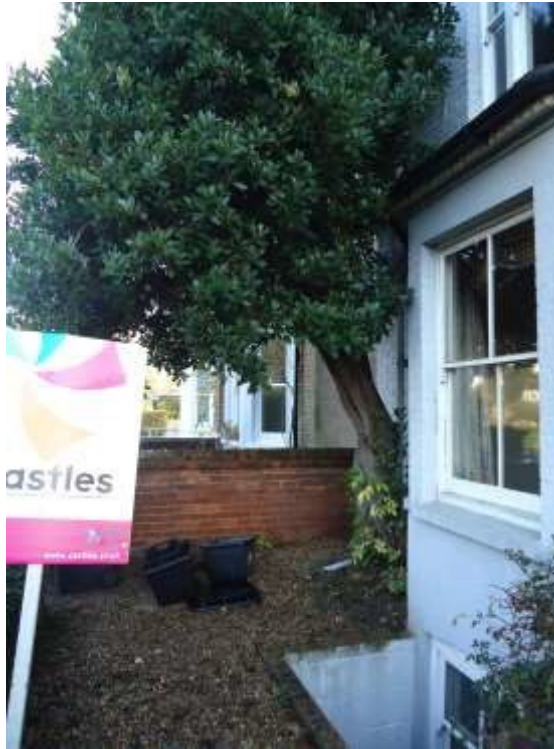
Ground shrinkage can be increased by the presence of tree roots. Services below ground may also be affected and in this regard. Generally the surrounding vegetation is not considered to represent a significant risk although the well rooted tree located close to the front wall concerns us. Although we do not profess to have a specialist knowledge of tree and shrub types we believe the tree to be some form

of laurel shrub (*prunus lusitanica*) which has a growth rate in the region of 40 cm per annum.

While we noted no evidence of damage to the basement and foundations of the house we are a view that it is only a matter of time until damage is noted. In such circumstances specialist advice should be sought and remedial action, if so advised, prior to your entering into a legal commitment to purchase.

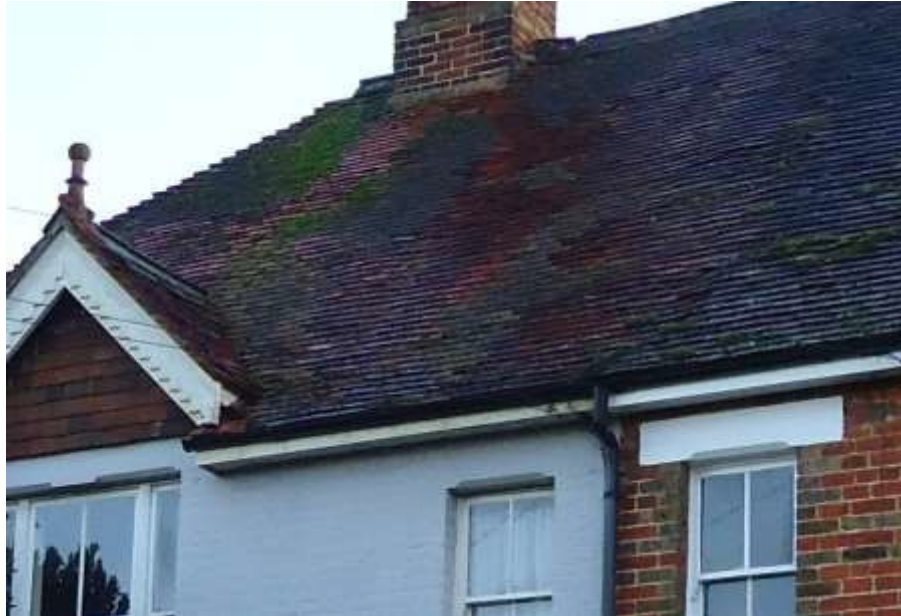
The main roof is covered with double lap tiles. These appeared in reasonable order although some mould growth was noted. Moss growth was noted on some roof slopes. This will impede the run off of rainwater and lead to gutter blockage. Ideally moss growth should be cleared off roof surfaces by a suitably qualified contractor. You should be aware that because the roof covering is linked into the neighbouring properties, you will need the agreement of your neighbours through a 'party wall agreement' should any work be needed on the roof surface close to their property in the future.

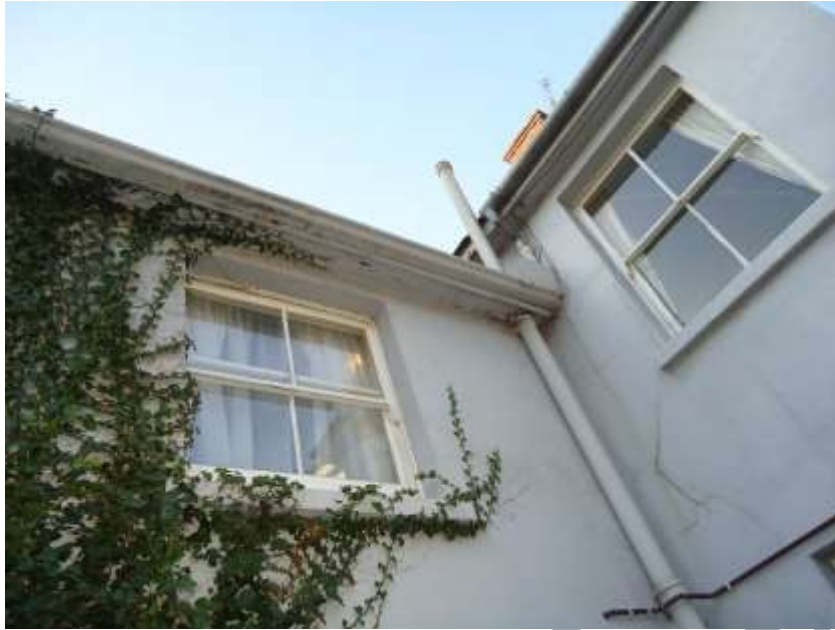
Eaves joinery is of timber construction. Observed timbers appear serviceable condition, but regular maintenance will be essential and it is highly likely that replacement and repair will be required, particularly on the rear defective wall.

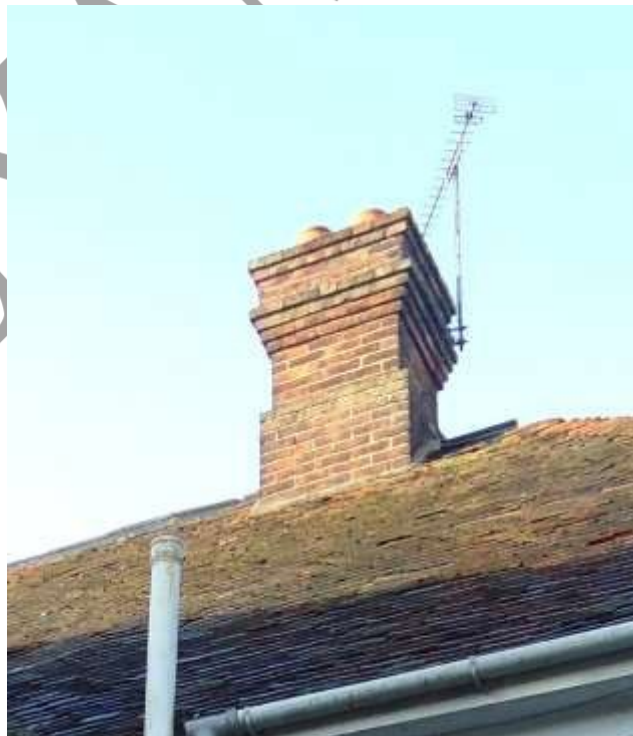
The property has a single brick built chimney stacks located above the centre of the property. The flashings are of cement mortar type and should now be replaced with ones of metal type to stop damp infiltration noted on inspection.

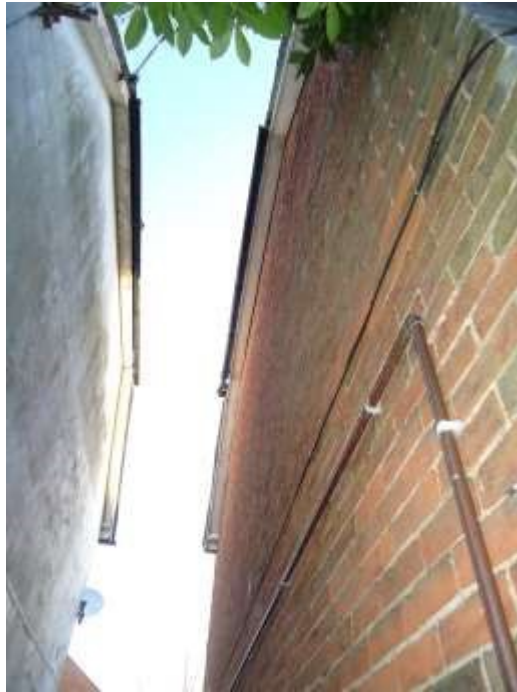
Main walls are believed to be of early cavity wall construction type with a thickness of approximately 275 mm. Cavities are formed by two skins, usually of block and brick, which are tied together by metal ties. Problems have arisen in the past where ties have broken and caused structural problems in the outer wall. No evidence of this defect was noted at the time of inspection. There is some evidence of previous brick repairs which appear to have been undertaken satisfactorily. Some repointing of mortar jointing will be required.

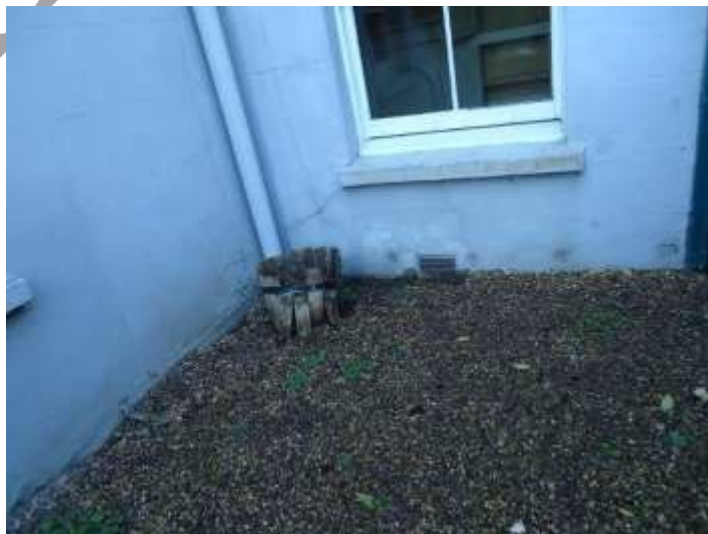
The front elevation has a painted finish while the rear wall finishes are rendered. These finishes conceal the true identity of the wall beneath. They may even have been applied to mask previous defects such as surface deterioration or worn pointing.

Cracking of render surfaces were noted indicating that such attention will be required soon. Given the envisaged repair work needed elsewhere, to counter water damage, It may be that large amounts of the rear wall render finish will need to be hacked off to provide access and to allow evaporation of trapped water vapour.

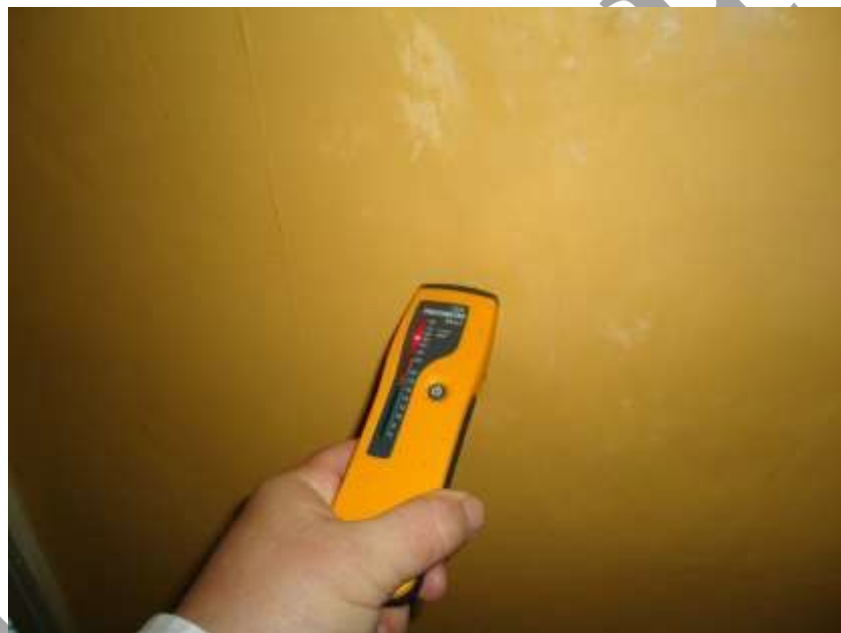
Given the level of dampness found in most external walls we doubt a damp proof course is in place or, if it is, It is now no longer effective. As highlighted under "dampness" below remedial damp works are required and specialist contractors should be engaged.

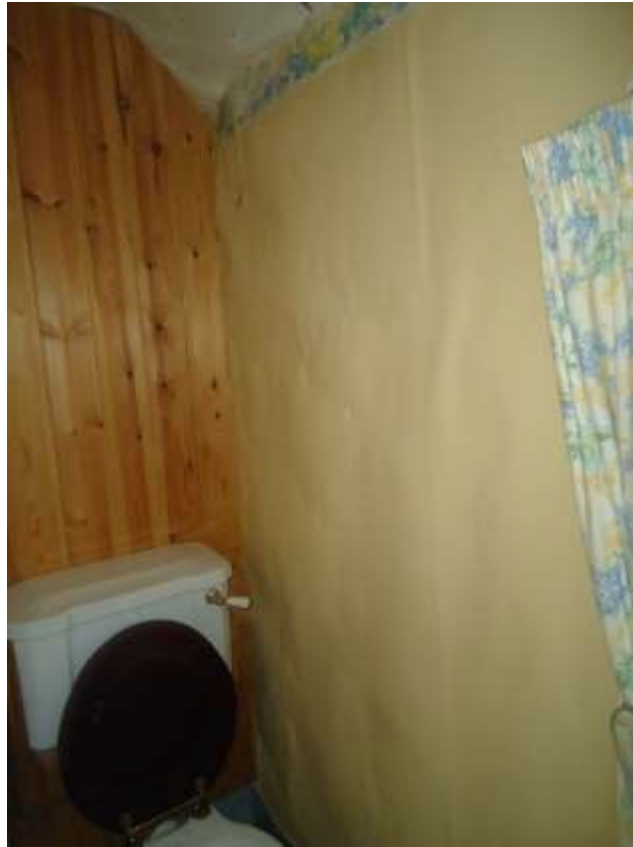
The internal walls and partitions are of solid wall construction with plaster finish to all elevations. Some walls have a structural function carrying the weight of the roof down to the foundations. In this respect, they are performing satisfactorily. The plaster finish to internal walls is fair although where water damaged has occurred such finishes have degraded and complete repair and re-plastering will be needed, after damp proofing repairs are effected, which will be extensive.

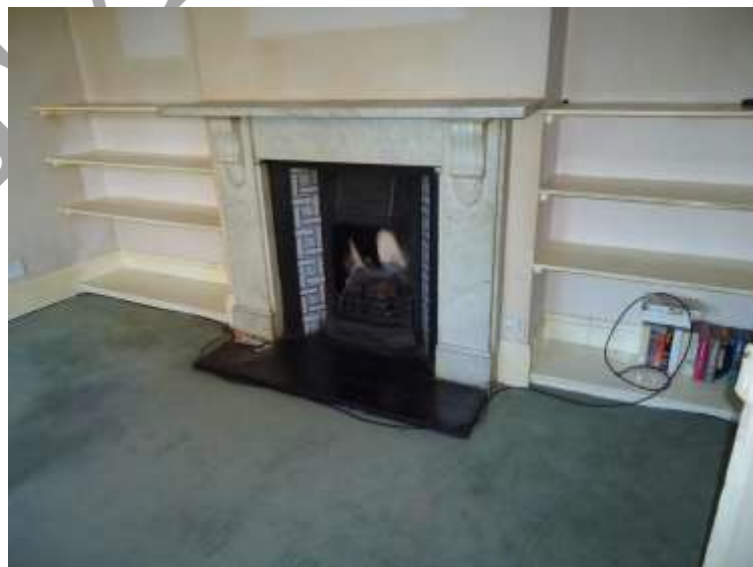
The property has two fire places located in the main reception rooms. A gas fire was in place in the living room while the rear fireplace has been boarded up. We believe a joint flue is in place and that it will be possible to use both as working fire places. However, we have not been able to make a full inspection and cannot give any warranty as to their condition. If you intend to use them then a full inspection and cleaning of the flues will be required prior to first use. Please note our advice regarding the inspection of gas appliances outlined below.

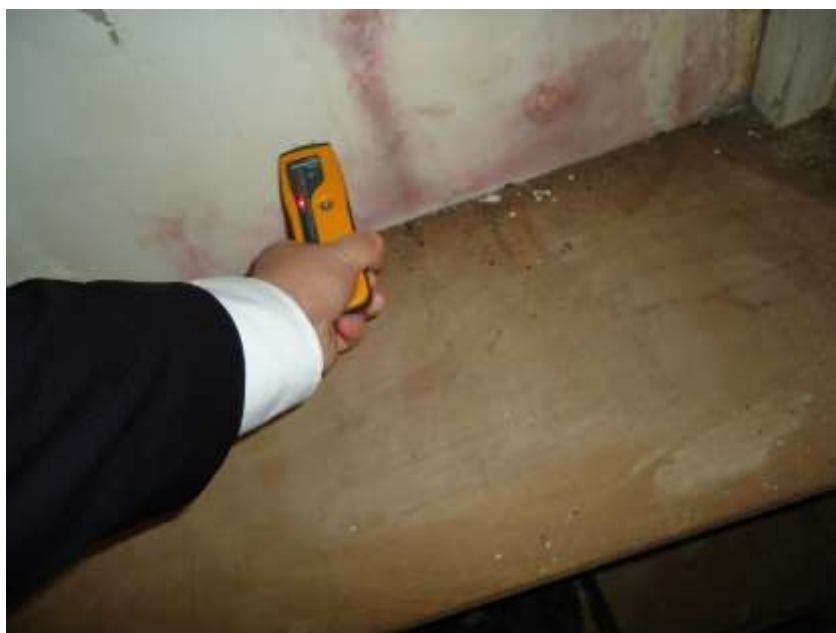
The property has a basement. Being subterranean basements are notorious for dampness and damp ingress. It is possible to avoid this by a number of measures involving the installation of a damp proof membrane, generally known as “tanking”. Experience dictates that whatever type of damp proofing is installed such provisions will have a limited life with further attention being required from time to time.

Such a finish has been installed in this property but has now failed. We noted high levels of dampness in both the internal walls and the floor slab. In its present condition the basement cannot be safely used for any other use than storage. Renewal of “tanking” finishes is expensive with a wide variety of types available; with a similar variety of cost and effectiveness. Specialist advice should be sought.

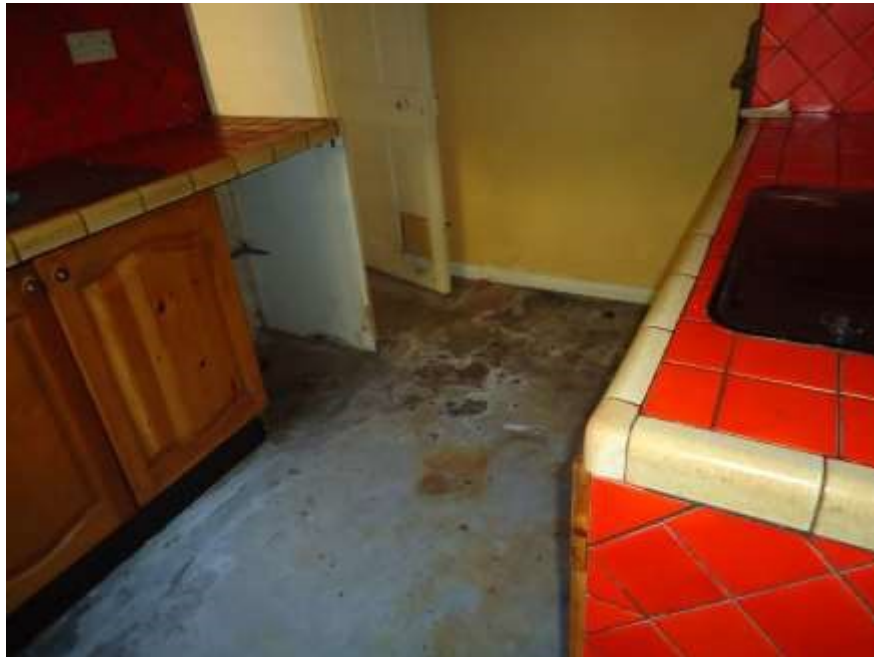
Extensive water staining was found on the uncovered areas of the solid part of the ground floor. We believe these have been caused by overspill leakage from, now removed, kitchen appliances, however, we cannot discount the possibility that such staining may be caused by the lack of a damp proof membrane in the floor slab. As part of the further assessment of remedial works for damp repairs a specialist contractor should be engaged to assess whether works to the floor slab are required.

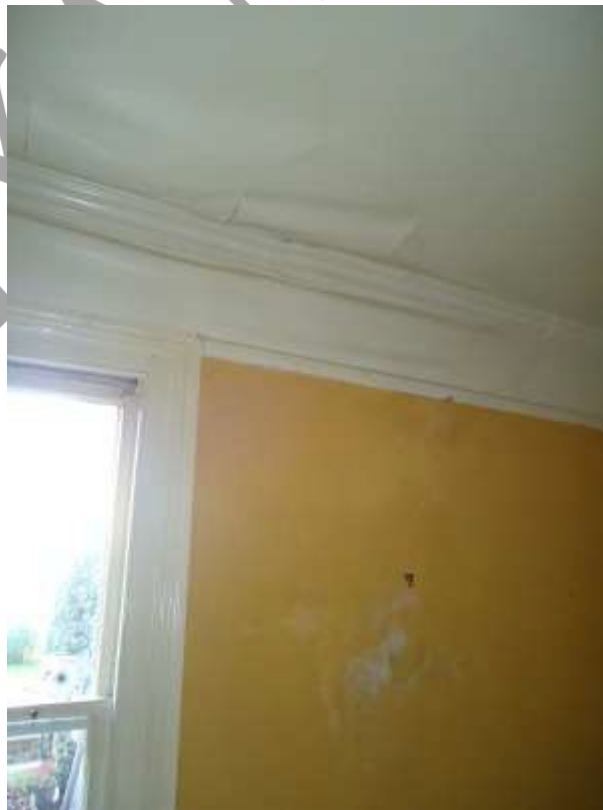
Ceilings are of plaster construction and are in a reasonable state of repair. Water damage was noted in the middle first floor bedroom and repairs will be needed as part of general remedial action. Cost implications of repair should be taken into account in your purchasing decision.

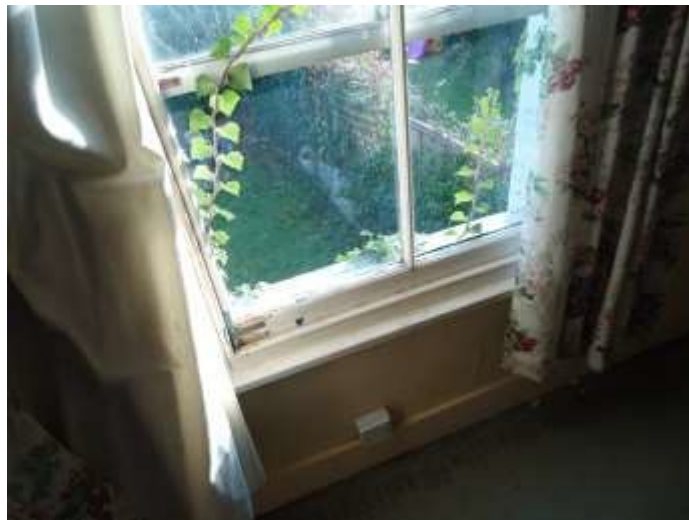
Window joinery is of timber construction and many are of sash fitting which have not been properly maintained. Complete overhaul of all units are required, indeed, replacement with new thermally efficient fittings, including double glazed panels may be sensible, although extremely expensive.

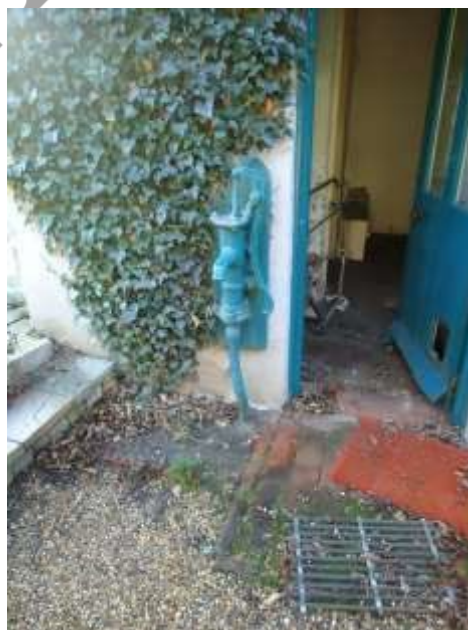
It is recommended that weatherproof seals be maintained between door and window frames and adjacent walls in order to minimise the risk of damp penetration internally. The external doors are of timber construction. The main entrance door is function while the rear requires replacement, presently, being a security hazard.

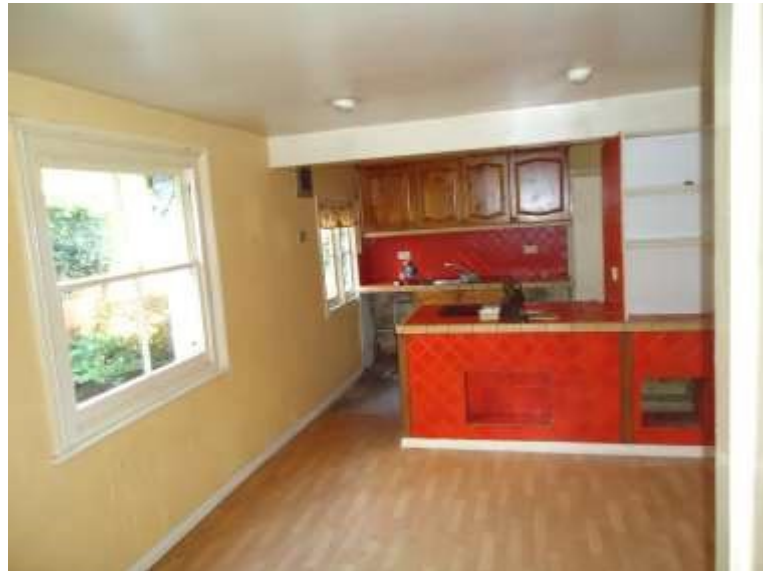
Kitchen joinery is in a poor state of repair and is considered inadequate by modern standards.

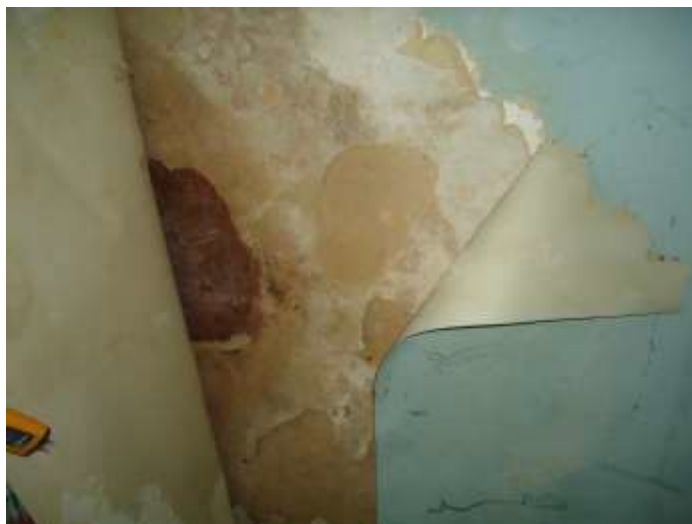
3. The rear and side wall of the dining room
4. The rear wall of the middle first floor bedroom, where extensive interior damage has occurred.
5. The bathroom wall, situated close to the toilet, where plaster is badly affected.

2. Dampness found in areas 3-5 have been caused by an amalgamation of leaks in the roof, faulty rainwater goods/stack pipe combined with waterlogging of the wall structure which, in turn, has led to degrading of both the interior and exterior surface. Repair of this area will require hacking away of all internal and external surfaces, rainwater goods, roof elements and timberwork, isolation of the precise cause, drying out of all water affected items and making good of all internal and external finishes. This will be a costly exercise and will cause considerable inconvenience so should be undertaken prior to your occupying the property.

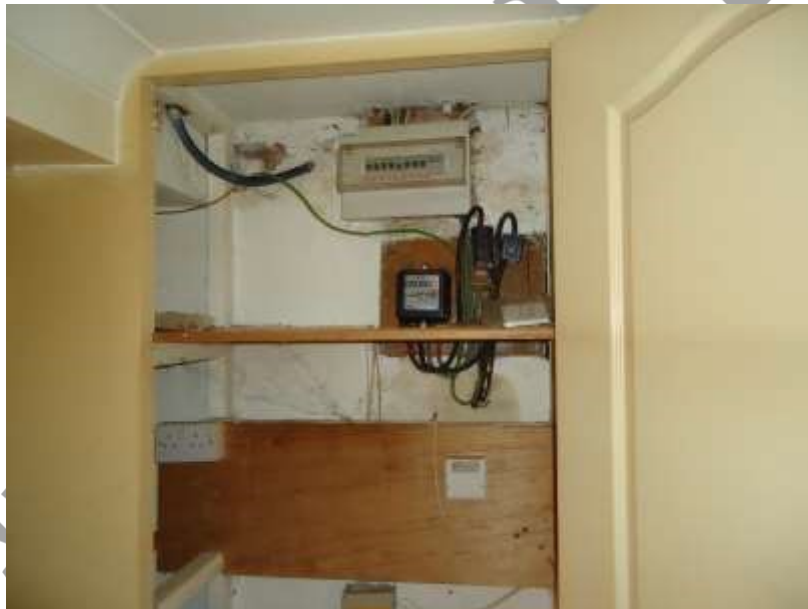
Mains electricity is connected. Observed wiring and fittings appear dated. **Ideally electrical installations should be inspected on a quinquennial basis therefore we recommend that a specialist inspection by a competent electrician (preferably NICEIC registered) is undertaken prior to your purchase and any recommendations be implemented.**

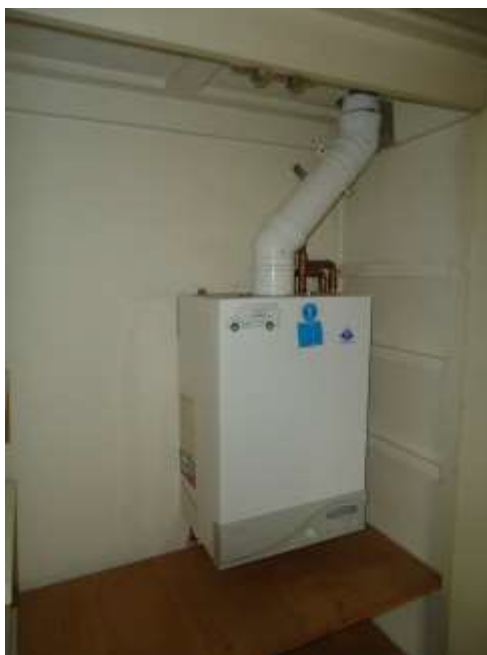
Hot water and central heating is provided by a recently installed gas fired boiler located in the rear first floor bedroom. Hot water is provided whilst room heating is from panel radiators within principal rooms. Such systems require regular maintenance and are incapable of providing hot water should the main electricity supply be terminated temporarily.

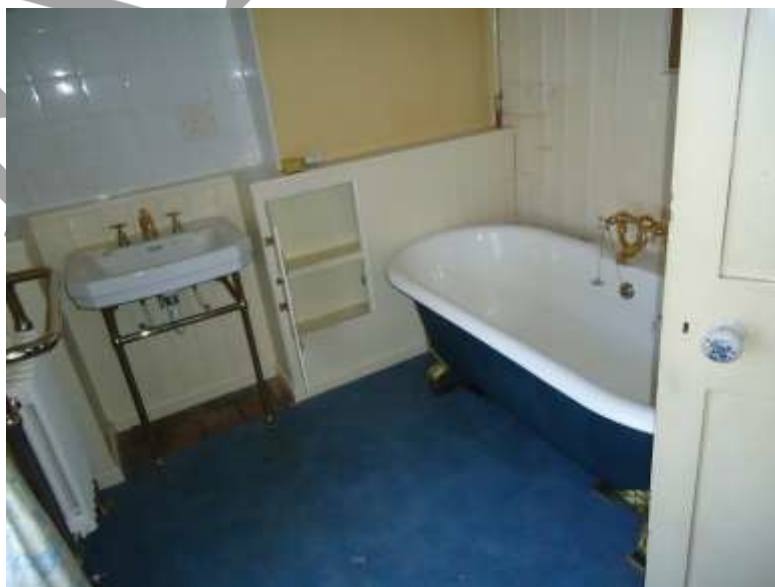
These are dated but usable. Flexible sealants should be maintained at the junction between sanitary appliances (particularly around baths) and surrounding wall surfaces to minimise the risk of water penetration to areas beneath. Regular checks and occasional renewal should be undertaken.
