Referral Letter
Baker Produce

10-24-11-HydroFLOW C-60 Unit installed on 3 Industrial Water Heaters

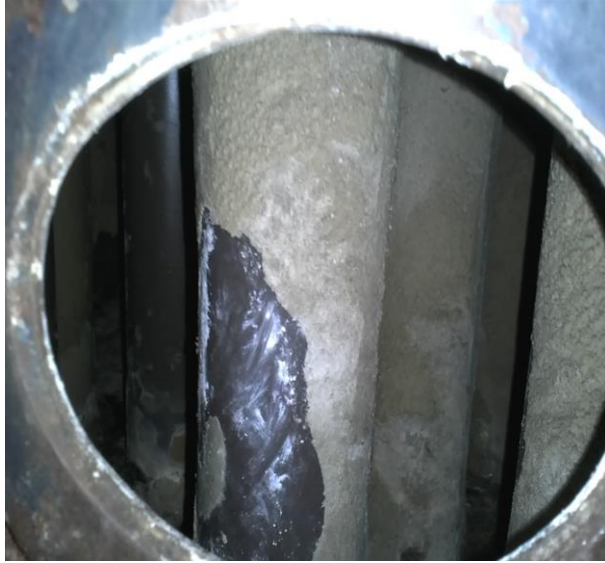
11-08-11 Here we see thick hard Scale early on in the Process. This scale had to be with a special tool (see the marks).

(Before HydroFLOW)
Water Heaters Serviced
Every 2 weeks for 5 hours

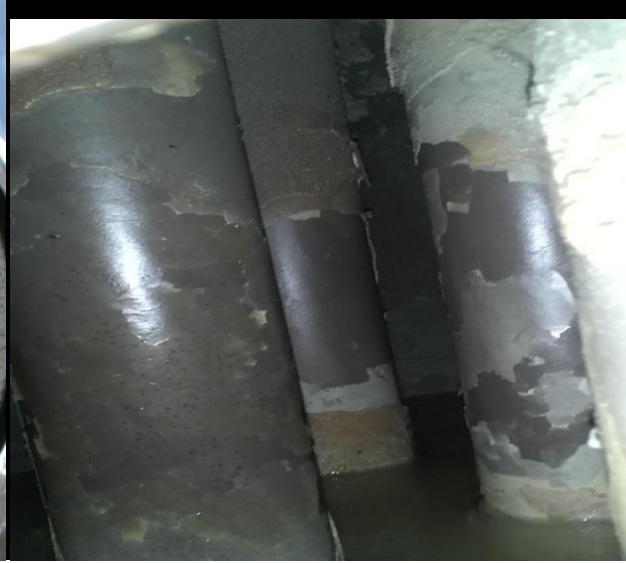
1-14-12—Here we see thinner Scale. Removal is much easier as Scale gets thinner.

(After HydroFLOW)
Water Heaters Serviced
Every 3 weeks for 3 hrs

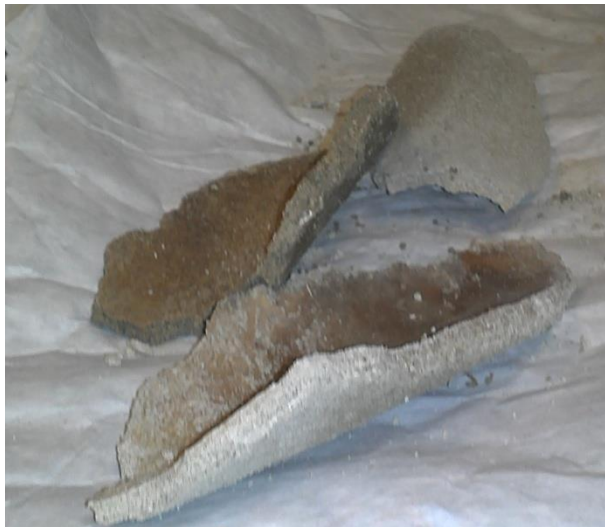
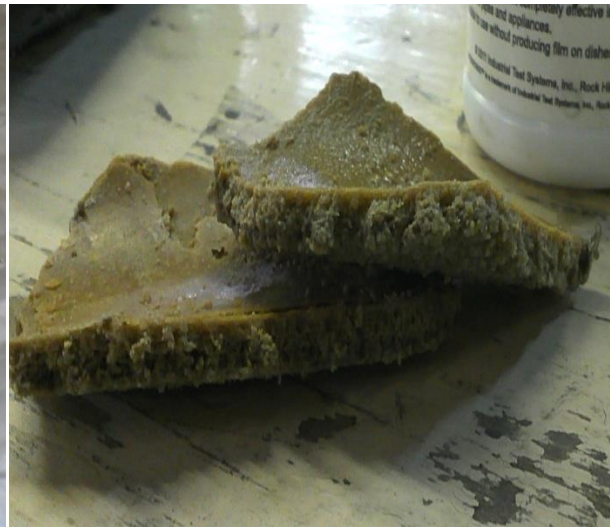
Above we see 6mm thick pieces of Scale that came off the tubes of Water Heater Tank

****“For every 1mm of scale approximately 10% heat transfer loss results”***

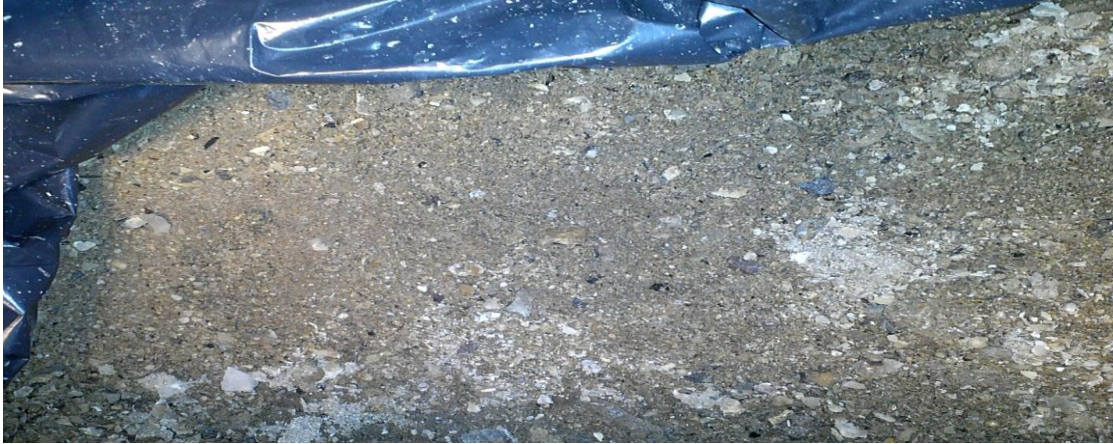
Here Just over 1 month we see Scale that was much easier to remove.

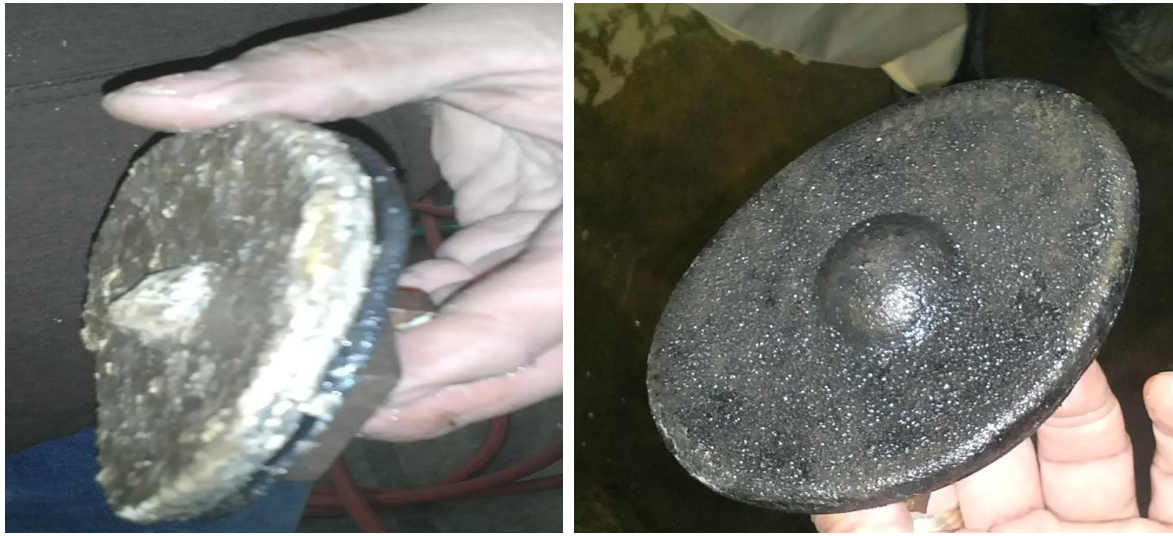
Here are Before and After HydroFLOW Photos of Water Heater Faceplates.

Before--HydroFLOW Jose had to put the Faceplate in a vice and hand grind the rock hard scale off the plate

After---HydroFLOW the scale doesn't even stick to the faceplate. If there ever is any it just falls off with a tap.
