RE: Corr-Ze 100™ & Corr-Ze 200™

CHASSIS FOR UTV PERSONNEL CARRIER

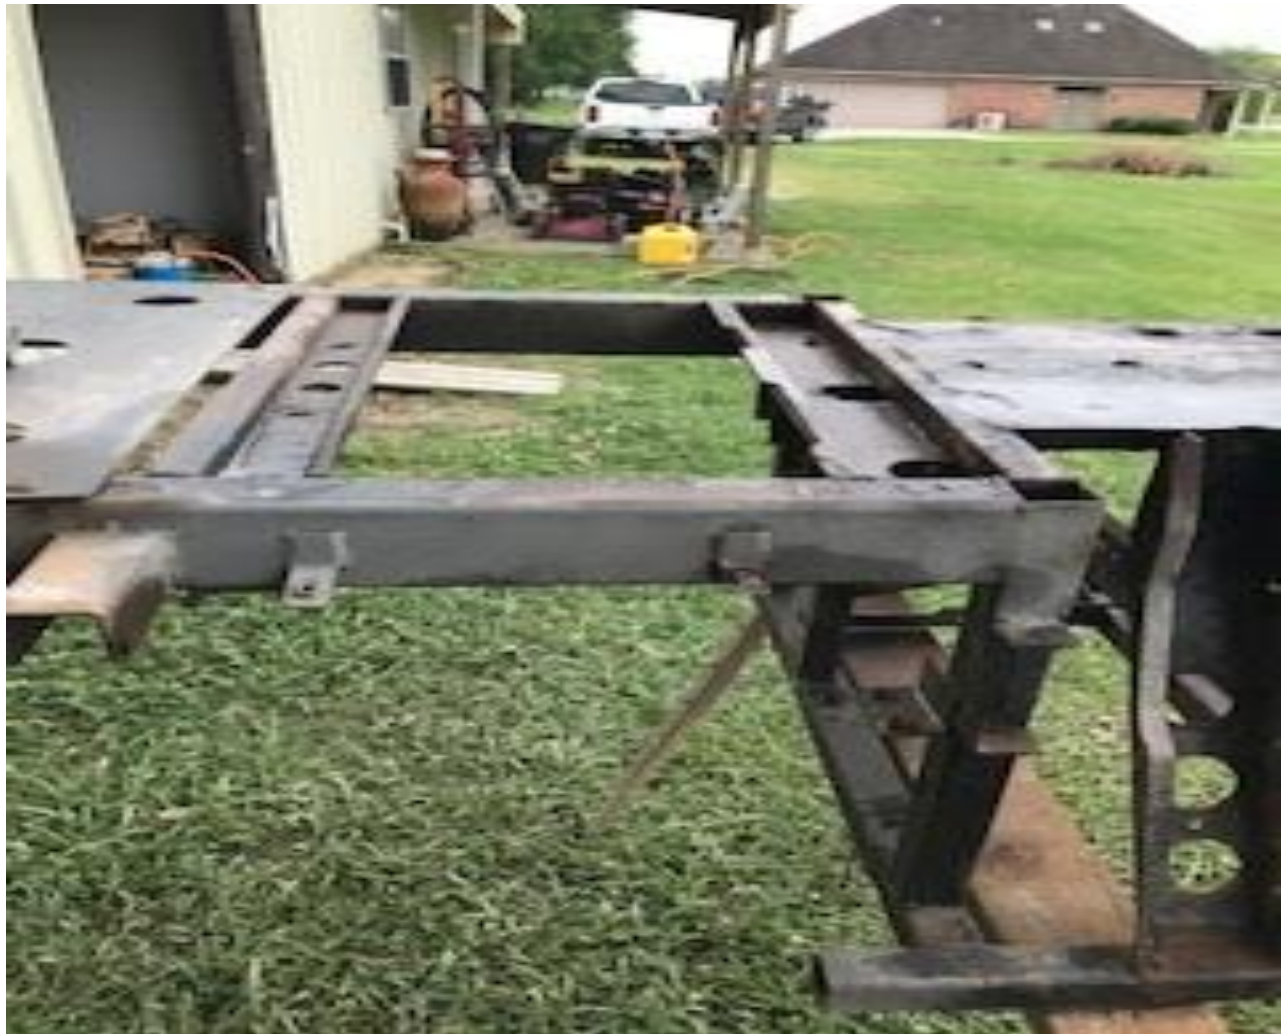
Wet abrasive vapor blast with Corr-Ze 100™

1. We removed all essential working parts from the chassis itself.
2. A portion of the chassis was vapor blasted using a fine abrasive and 1:100 mix of Corr-Ze™ 100 in the water.
3. The chassis was rinsed (washed down with no abrasive) with a 1:100 mix of Corr-Ze 100™ and allowed to dry.
4. The surface was again tested for soluble salt contamination and the readings were ***non-detectable***.

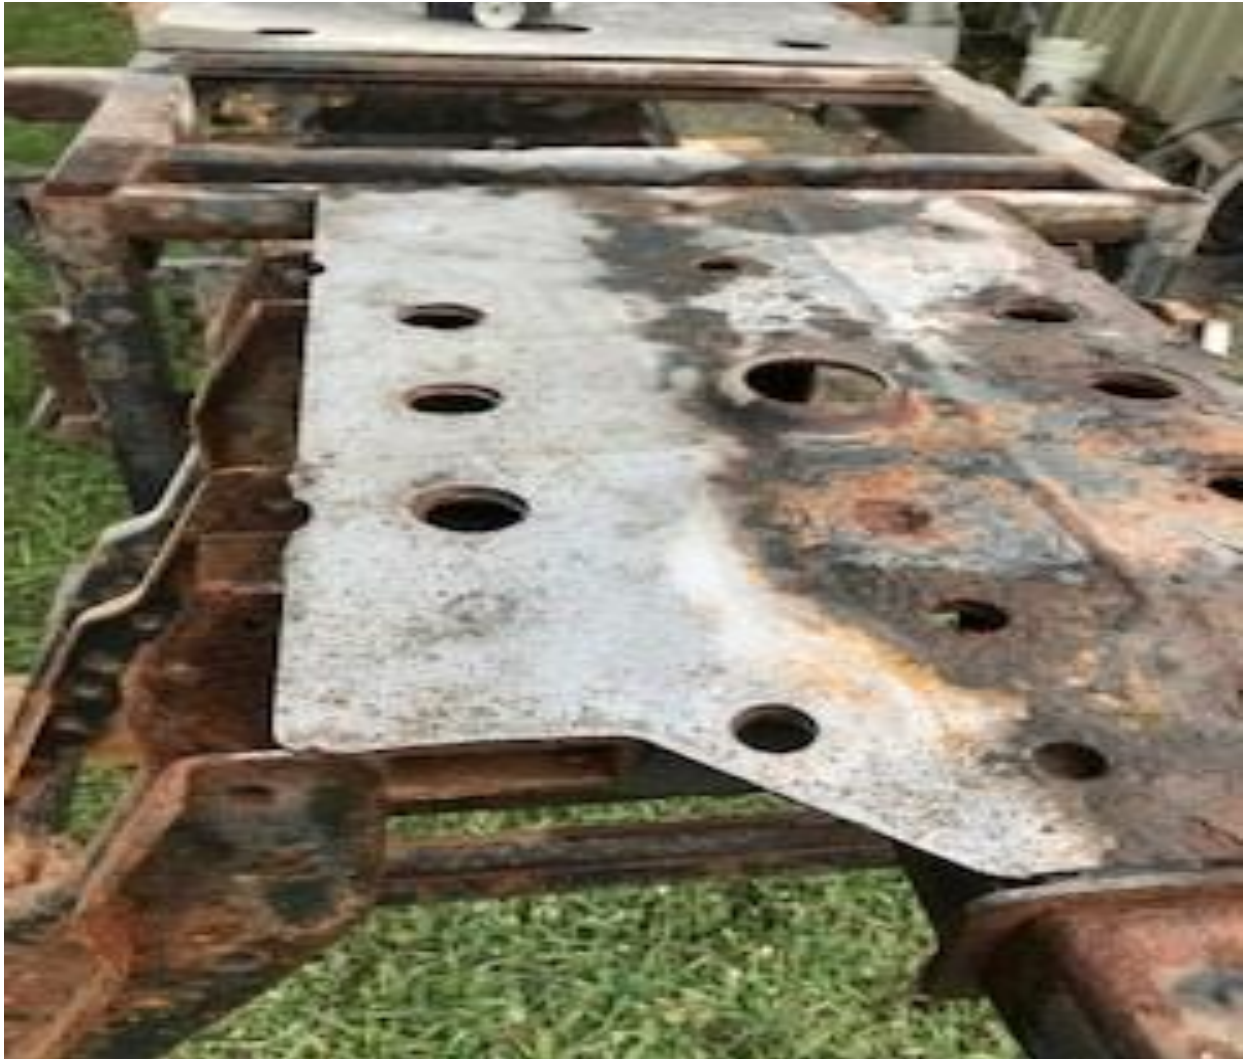
Corr-Ze 200™ treatment

1. The remaining portion of the chassis was vapor blasted using a fine abrasive and clear water **without** the Corr-Ze 100™.
2. A soluble salt test was performed, test results again were maxed tube readings.
3. The chassis was allowed to rust for a few days before applying the Core-Ze™ 200.
4. Corr-Ze 200™ was applied at a film thickness of 12-14 mils as per recommendation and allowed to work for 30 minutes.
5. Once the 30 minutes had passed, we pressure washed the chassis with a 1:100 ratio of Corr-Ze 100™ for successful removal of the Corr-Ze 200™ and rust. The metal was white with no adverse effect to the profile.
6. The surface was again tested for soluble salt contamination and the readings were **non-detectable**.

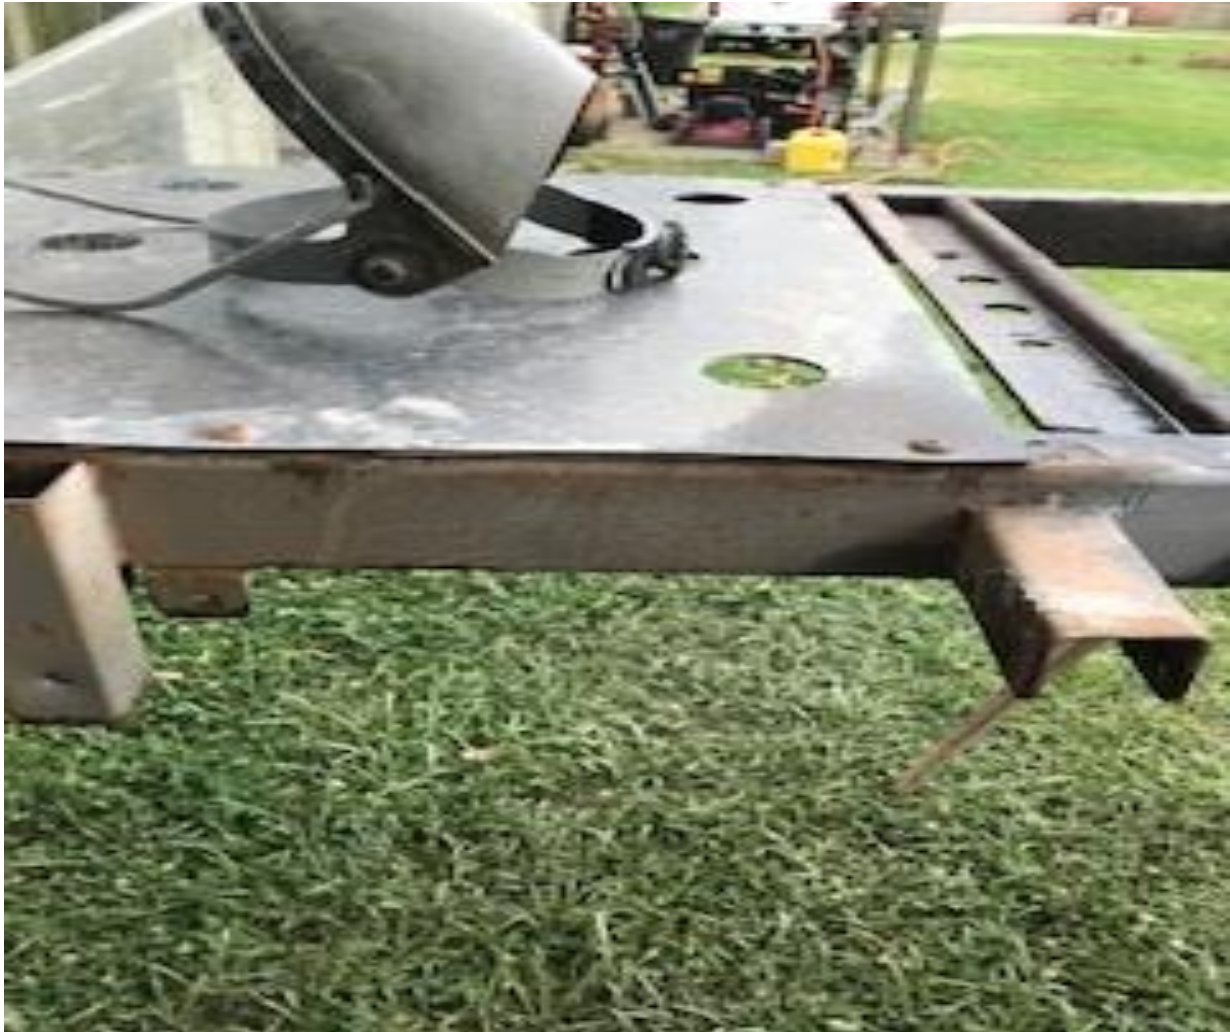
Corr-Ze 100™ rinse after Corr-Ze 200™ treatment

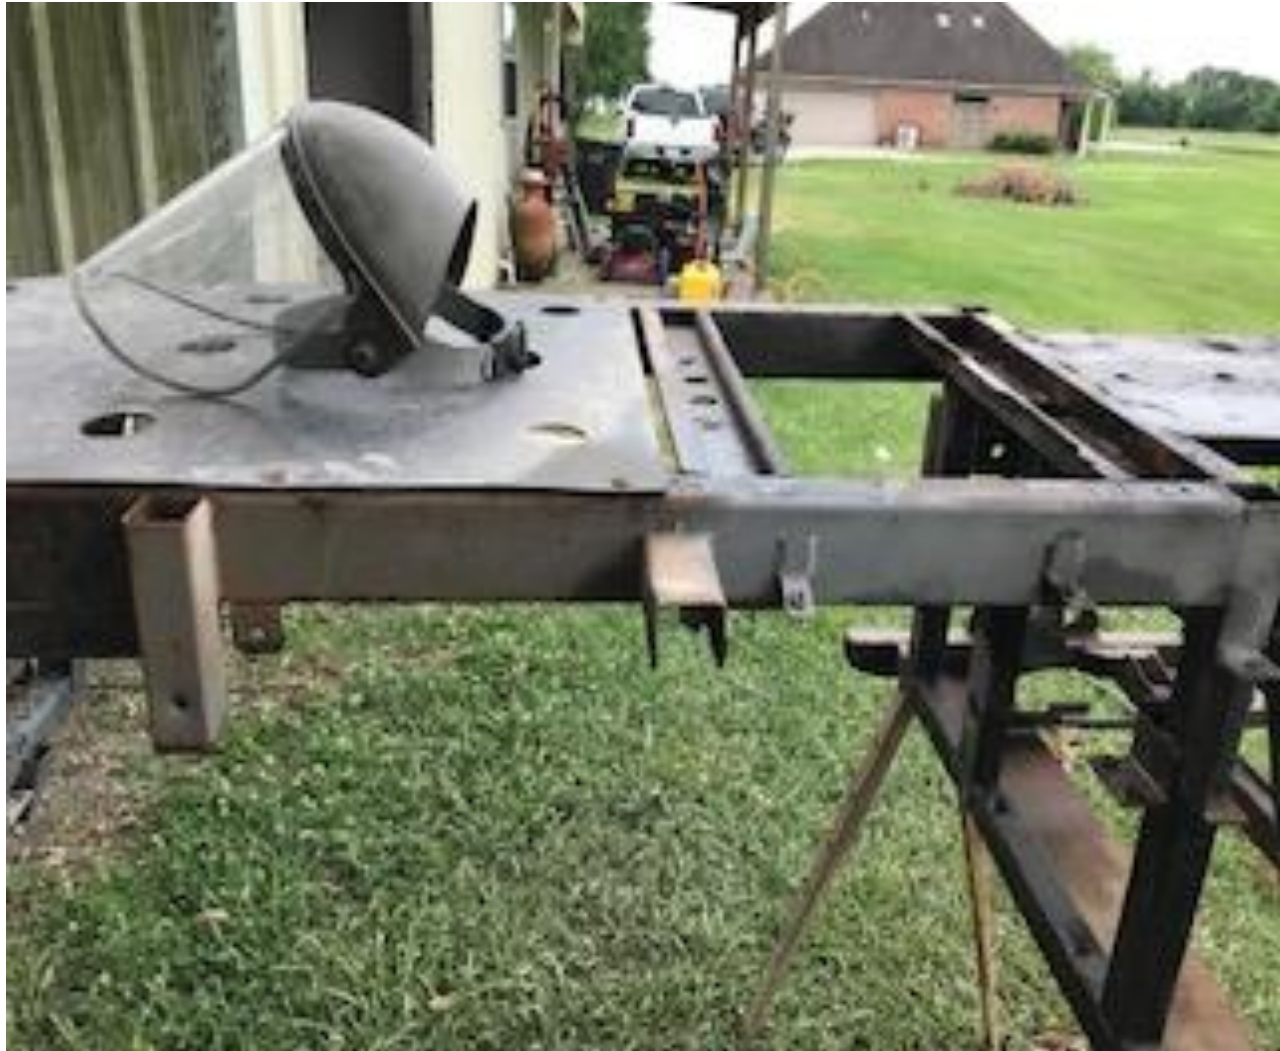
Corr-Ze 100™ rinse after Corr-Ze 200™ treatment

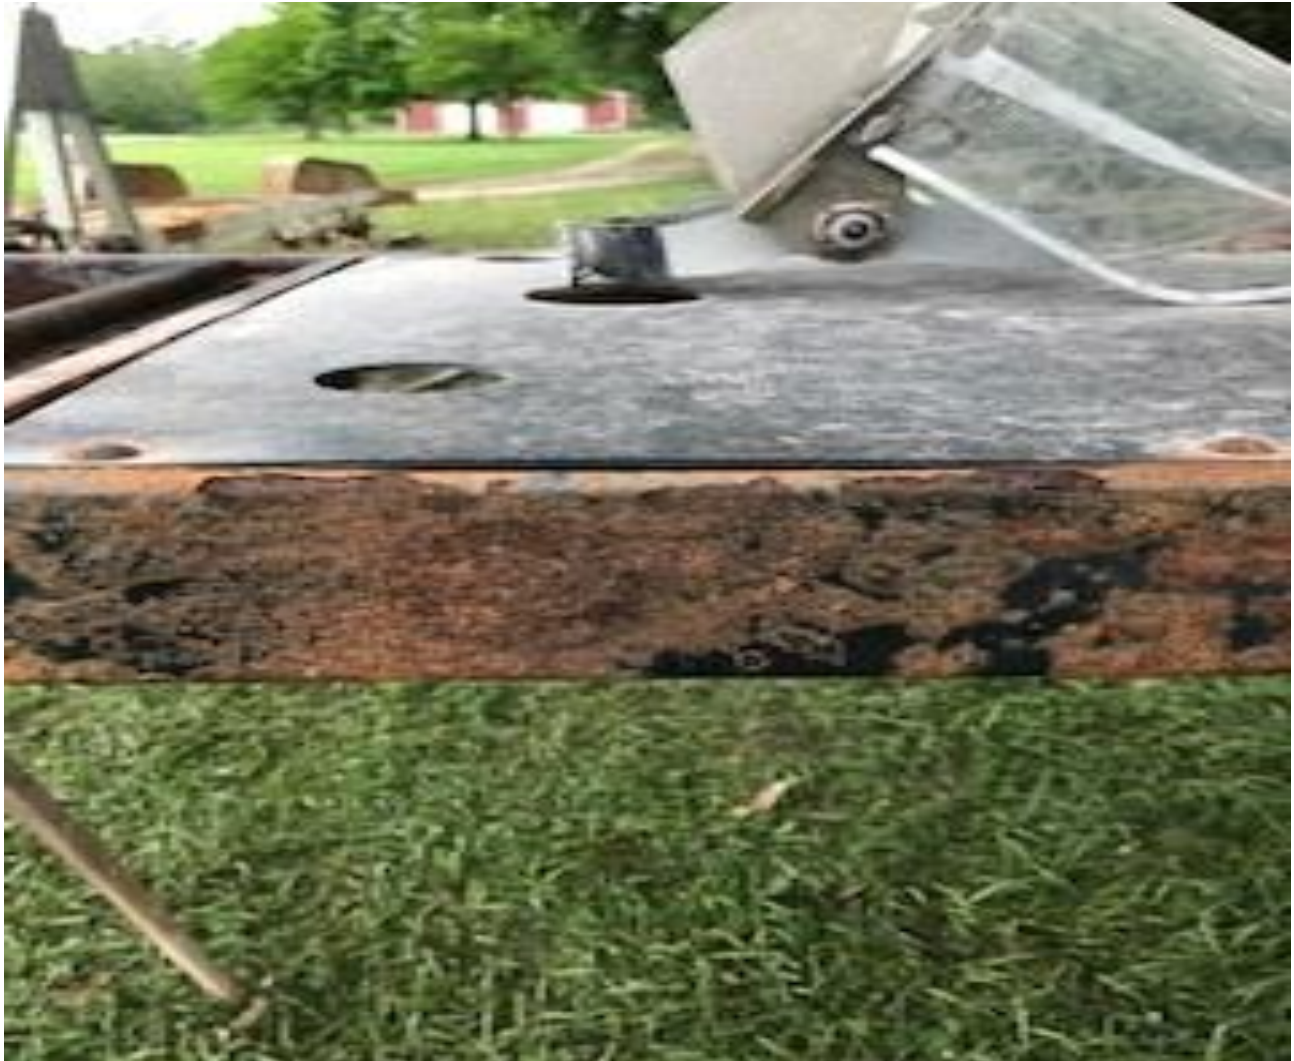
This equipment was used at one of the South Louisiana Salt Mines for transportation of personnel to various locations on the ground level of the island. It was brand new when delivered to the salt mine, and within 4 months it was extremely corroded due to extremely high salt concentrations there.

Heavily pitted corrosion was in effect causing the UTV to look as though it had aged several years! The corrosion was so severe several of the chassis' components had to be cut in order to disassemble the unit. All the fasteners had to be cut or drilled to remove.

New steel after only 4 months in a salt mine. Before & after treatment with Corr-Ze™ Products!
