CASE STUDY

Agri-Nutrients, Inc.

Fertilizer Storage Building

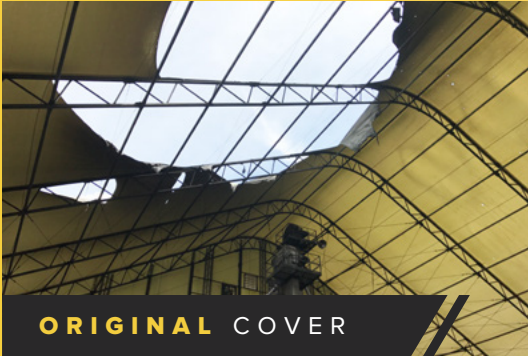
Finished recover by Legacy (above).

Legacy manufactured the replacement fabric based on existing drawings and field-verified measurements, and then our install teams traveled to Oklahoma to install the new roof and endwall fabric. Once the repair crews arrived on site, they worked around the schedule for Agri-Nutrients to get the company back to production without further interrupting business. “It was very interesting to watch them work,” said Ferrell. “They worked around our schedule to help us avoid a shutdown while the building was being repaired.”

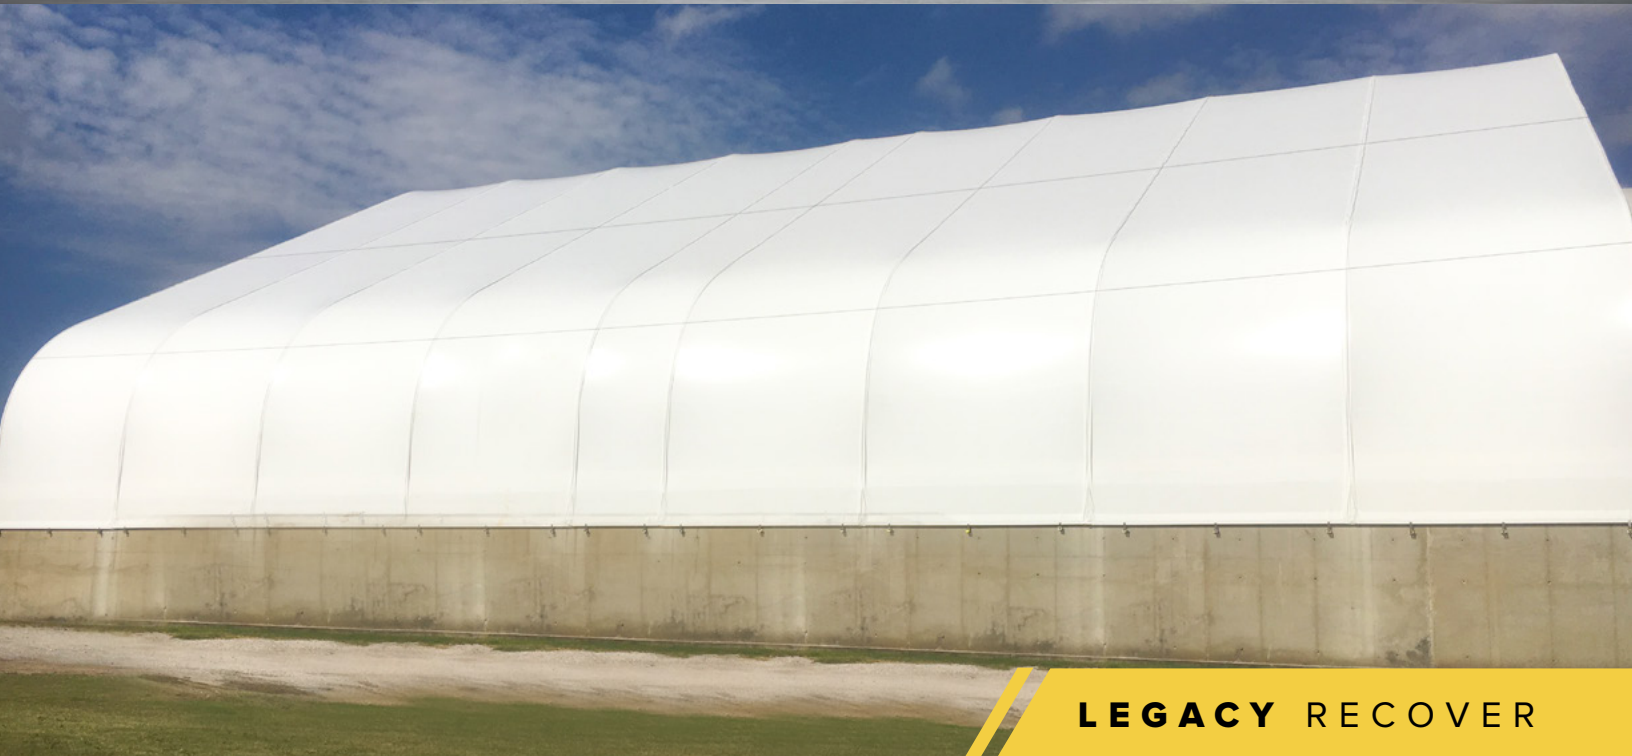
LEGACY RECOVER

Original structure after Legacy completed the recover.
