# RESISTANCE PIER FOUNDATIONS

Foundation Solutions for Settlement in Residential or Light Commercial Structures

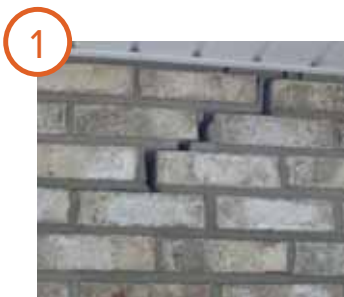
**1 BRICKS OR WALLS CRACKING**  
Stress cracks appear in the mortar of the brick veneer. Unfortunately, patching cracks with mortar does not fix the problem.

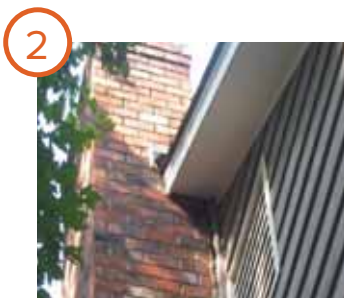
**2 CHIMNEY TILTING OR LEANING**  
Most chimney foundations are connected to home foundation and if it is tilting or leaning, it can be a sign of a structural issue.

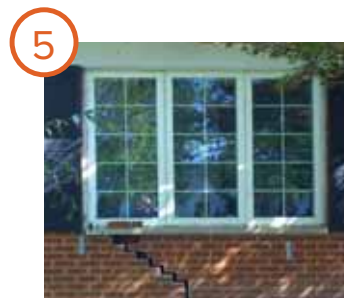
**5 DOORS/WINDOWS STICKING**  
Sticking doors and windows could mean that there is a problem with the foundation of your home.

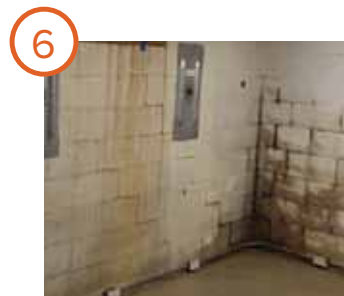
**6 BASEMENT LEAKING**  
A leaking basement, or standing water in a basement, can mean that potentially harmful water is not draining away from the foundation.

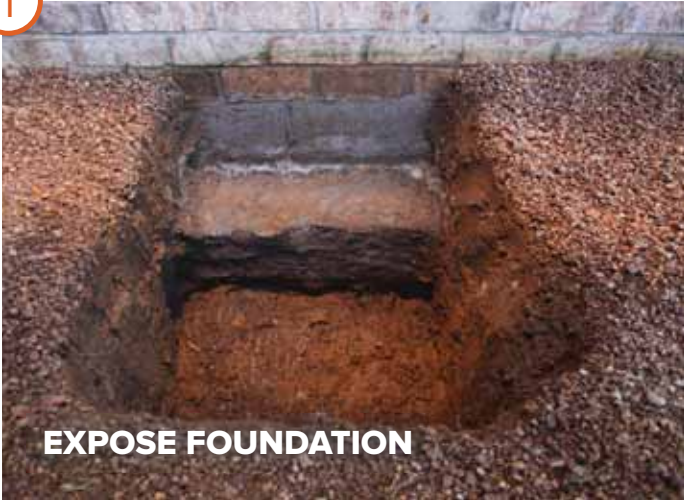
1

**EXPOSE FOUNDATION**

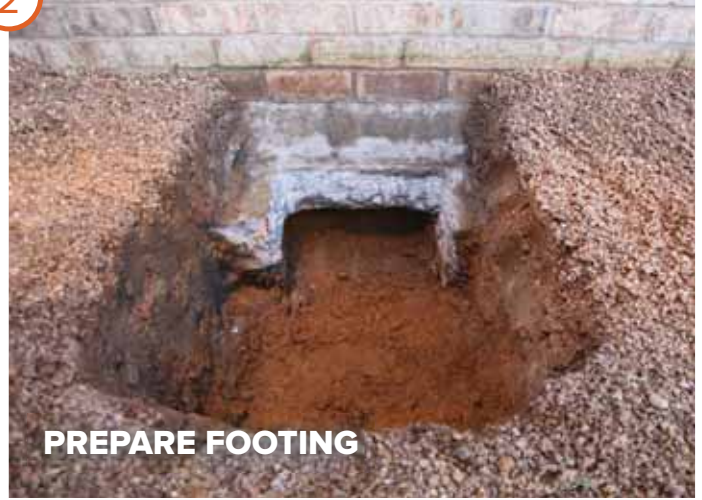
2

**PREPARE FOOTING**

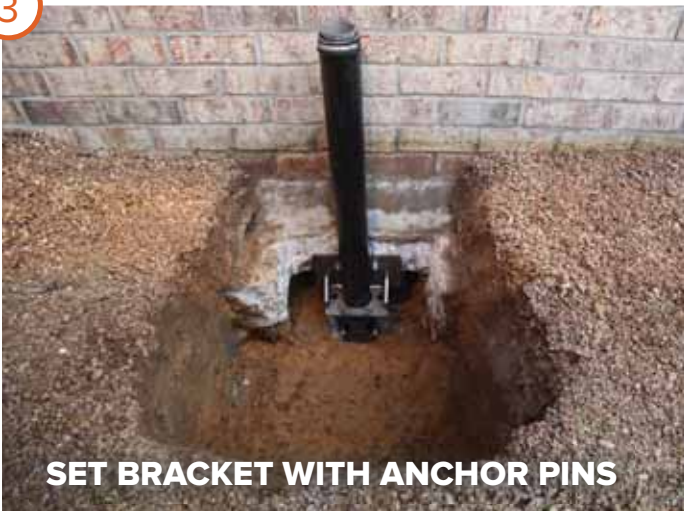
3

**SET BRACKET WITH ANCHOR PINS**

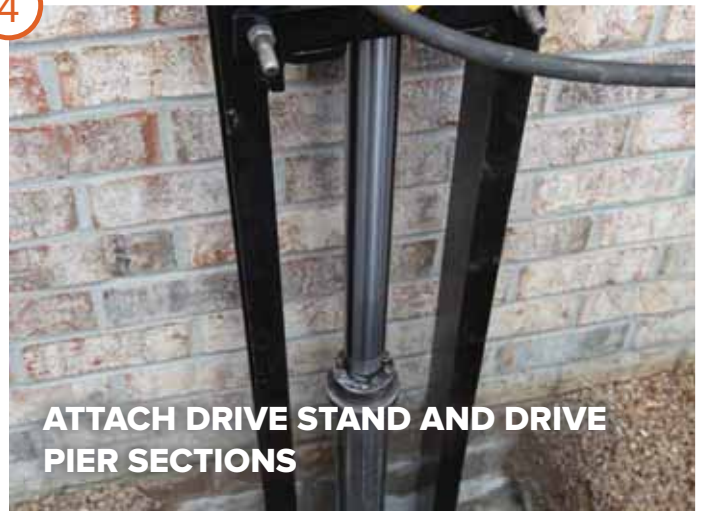
4

**ATTACH DRIVE STAND AND DRIVE PIER SECTIONS**

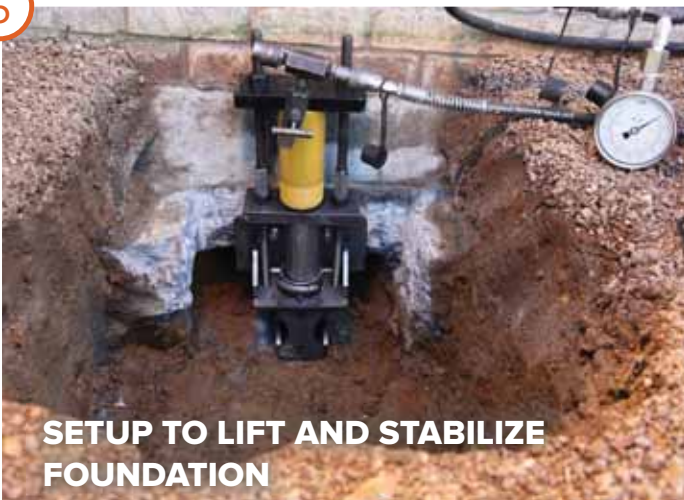
5

**SETUP TO LIFT AND STABILIZE FOUNDATION**

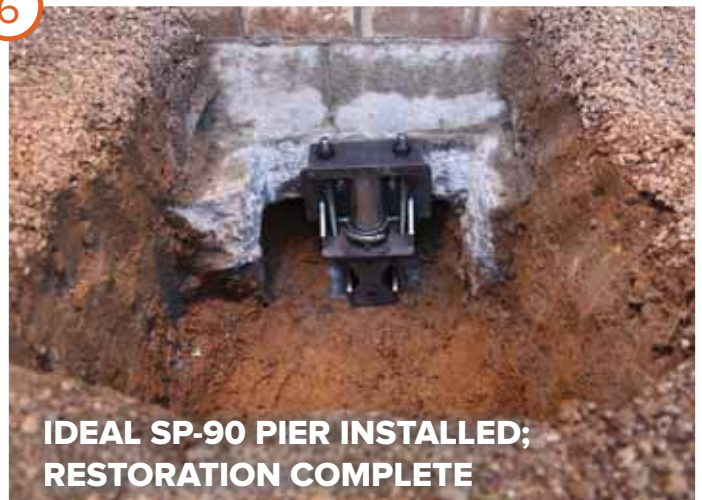
6

**IDEAL SP-90 PIER INSTALLED;  
RESTORATION COMPLETE**

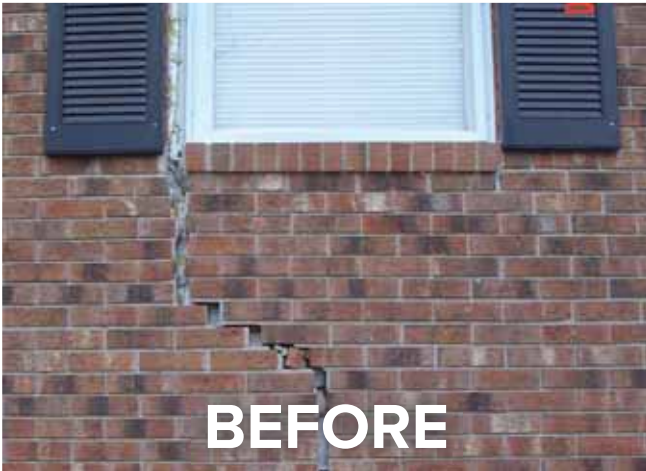
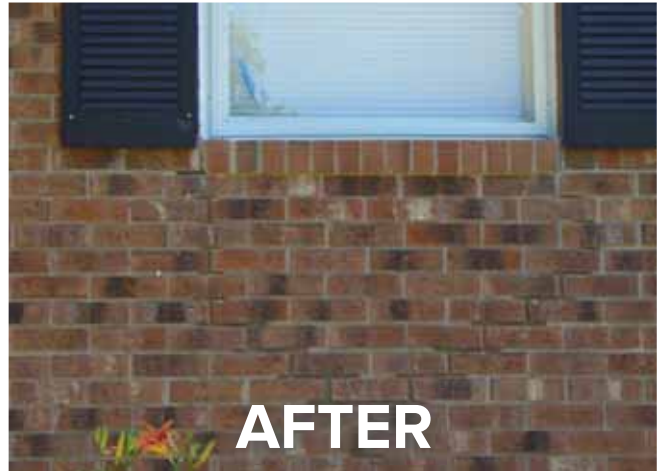
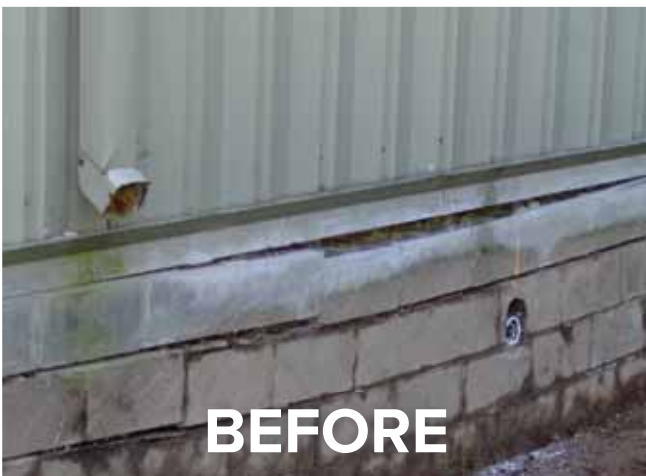
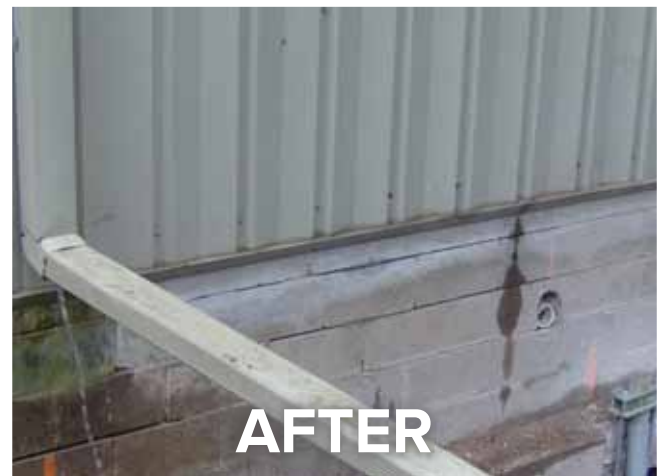
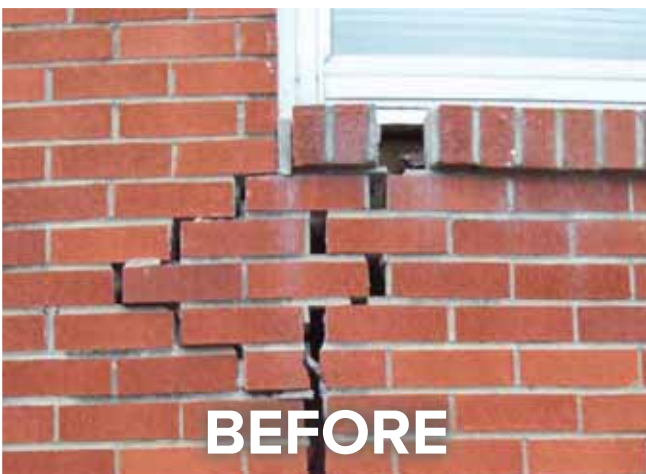
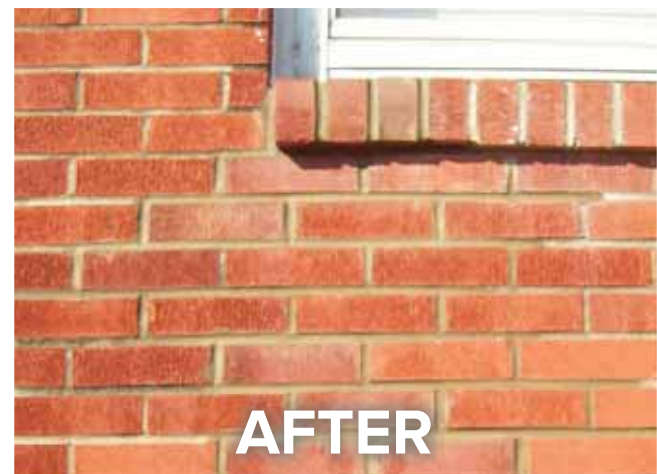
The Titan SP-90 is the solution for your home's settling foundation. When the Titan SP-90 is installed under your home's foundation, it's permanent. Guaranteed.

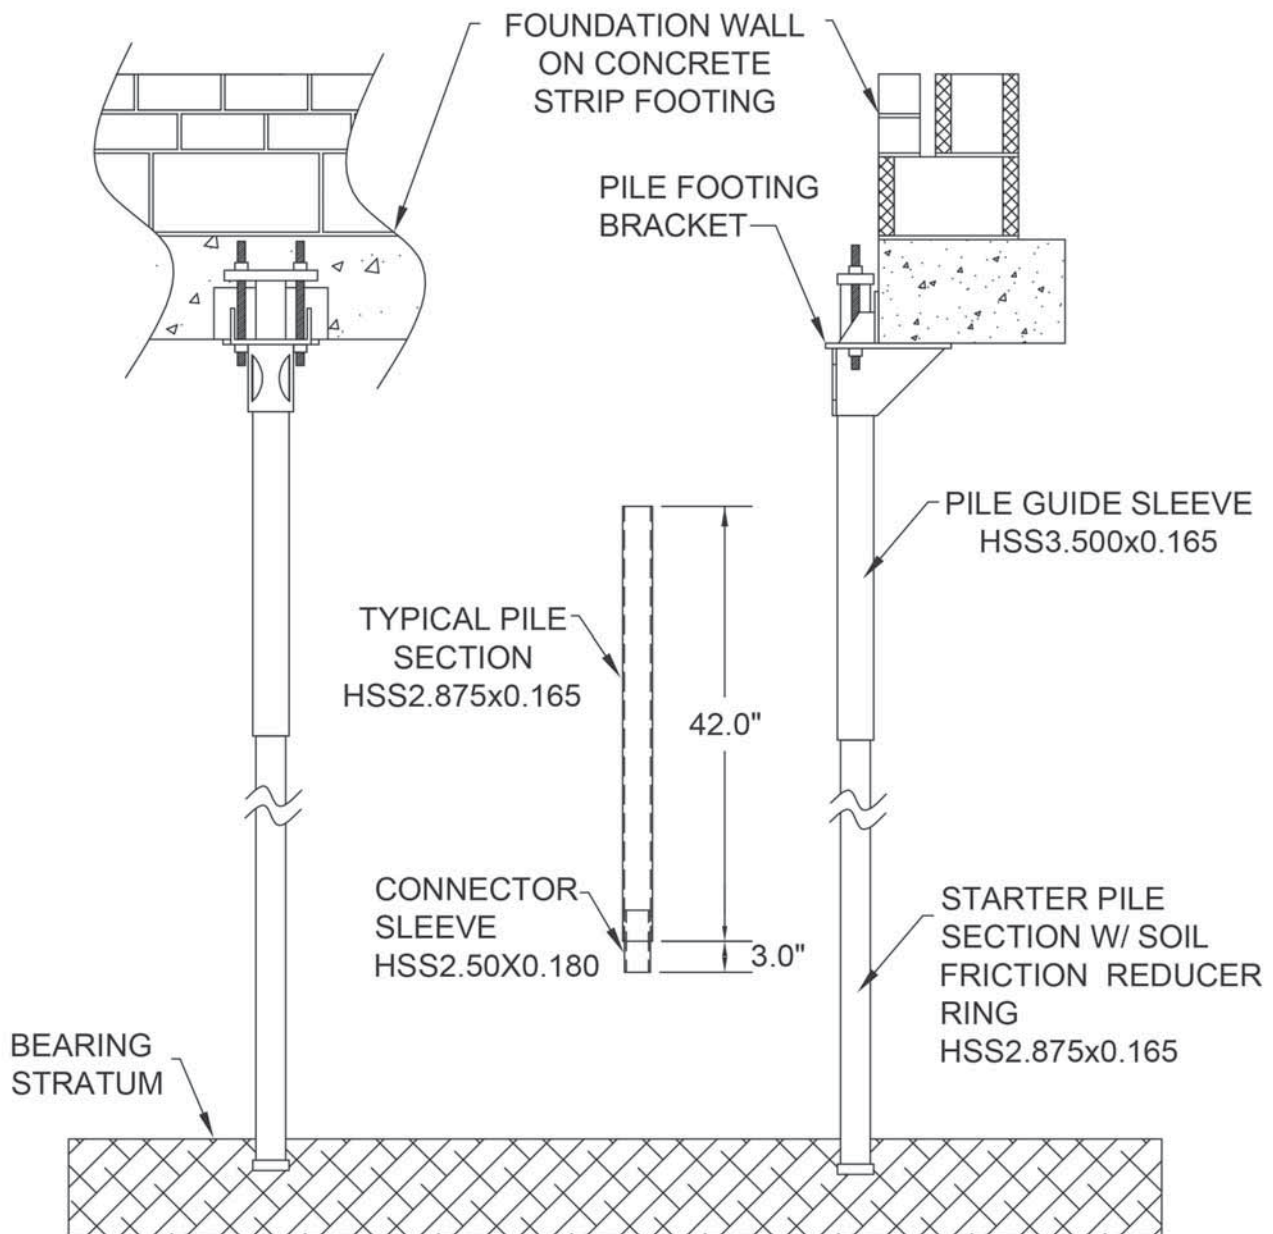
# TITAN SP-90 SPECIFICATION

- Ultimate Bearing Capacity = 90,000lbs
- Bearing Surface Area = 64 in<sup>2</sup>
- Soil Friction Reducer Ring
- Installed with Portable Equipment
- Piles are Field Tested During Installation
- Manufacturer's Limited Lifetime Warranty
- Guide Sleeve Help Insure Vertical Alignment and Increases Pile Stiffness in Excavated Area

The capacity of the Titan SP-90 foundation support system is a function of the capacity of pier pipe and soil surrounding the pipe, capacity of the load bearing stratum, bracket, foundation strength and strength of the bracket to foundation connection. Actual capacities could be lower than the bracket capacity.
