Clogging of Automatic Flow Controllers

Subject and Scope

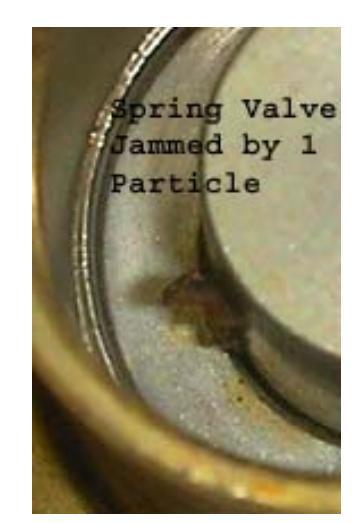
The predominant mode of failure for all of the metal spring valves was jamming of sliding members. Quantitatively, as few as one foreign particle can jam the sliding member due to the small clearances required to operate these valves at high pressures. Every one of the spring loaded devices jammed. They jammed during the first cycles of the tests, the amounts of the iron fillings that jammed those devices were below the measurement threshold. The most predominant mode of failure was the foreign object (iron particulates in our test) jammed in the gap between the sliding and fixed components as shown to the left.

When the tests were run for longer periods (in spite of the valves not functioning) additional material would accumulate in the narrow portions of the opening on the

flow control. Since the openings are small and do not open up at lower pressures the particulates would jam in the opening, further restricting flow to relatively low values.

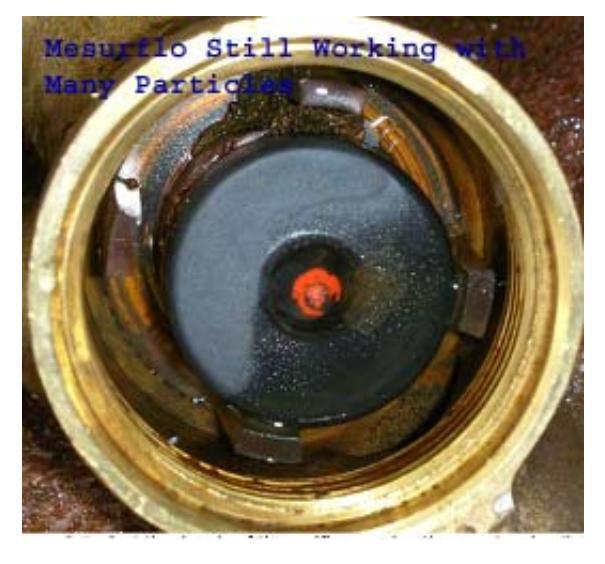
Mesurflo technology does very well with small particulates. The iron filings accumulate in the low velocity area around the base of the Mesurflo. As long as the opening between the orifice and diaphragm is large enough these particles pass through during the low pressure portion of the test, freeing the valve from contamination. A picture of the Mesurflo after the test at 0.8 oz/hr is provided to the left. The Mesurflo was still controlling flow!
