Our reference
V-USA-1-0-10

Subject: VELUX® SKYLIGHT REPLACEMENT CLADDING PARTS

Skylight Deck Mount Models – Pictorial

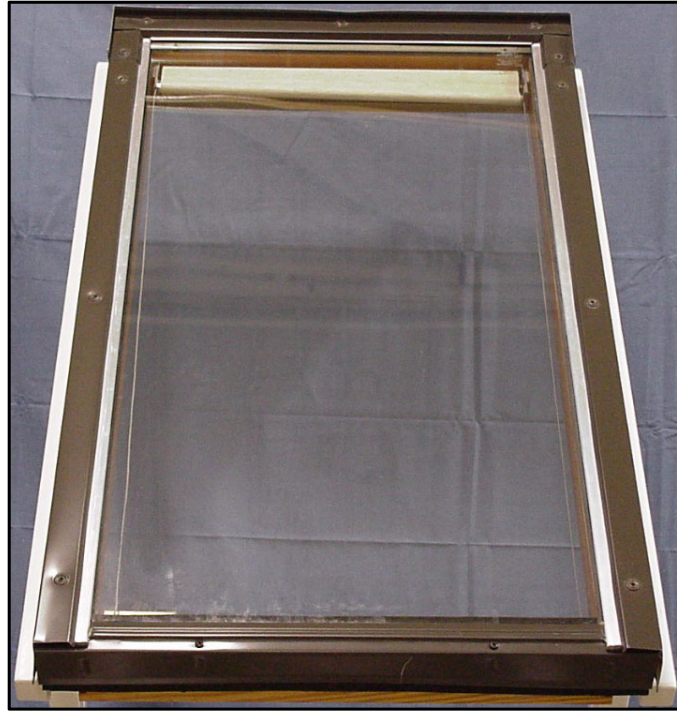
FS M82 / FS M85 / FS M87**Mfg 12/1982 – 03/1995**

No replacement cladding parts.
Skylight replacement only.
Distinguished by exterior screws
through the top of the cladding
covers

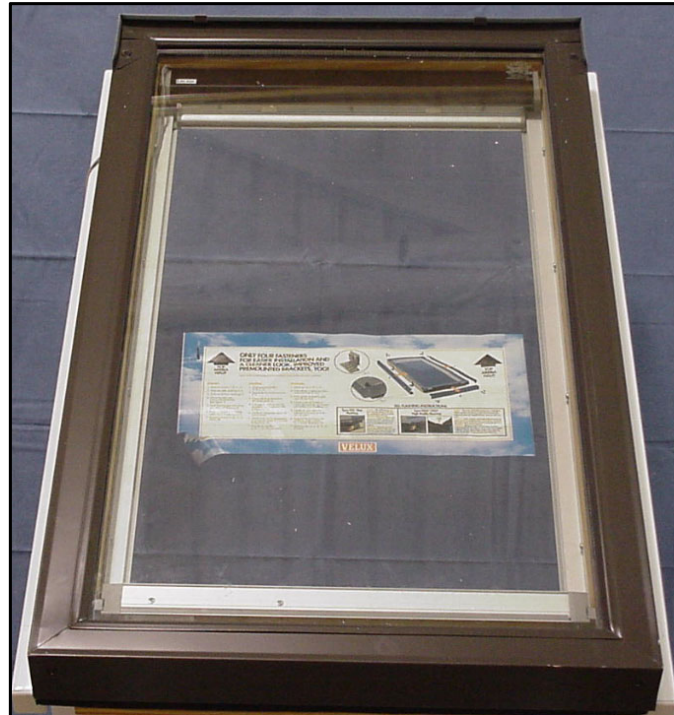
**FS M95****Mfg 04/1995 – 05/2004**

No replacement cladding parts.
Skylight replacement only.

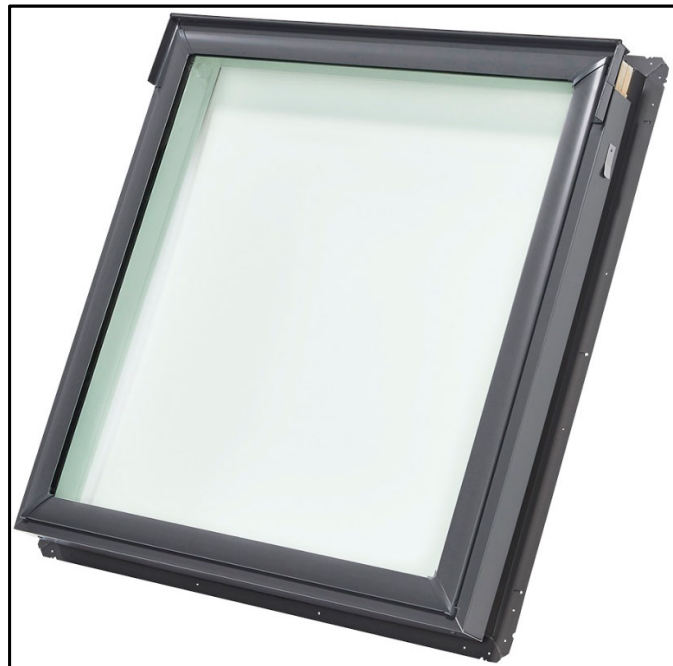
**FS A21****Mfg 01/2010 – Present**Replacement cladding parts only
for frame cladding covers,
otherwise complete skylight
replacement.Distinguishing features are
rounded glazing profile cladding
and light grey color.

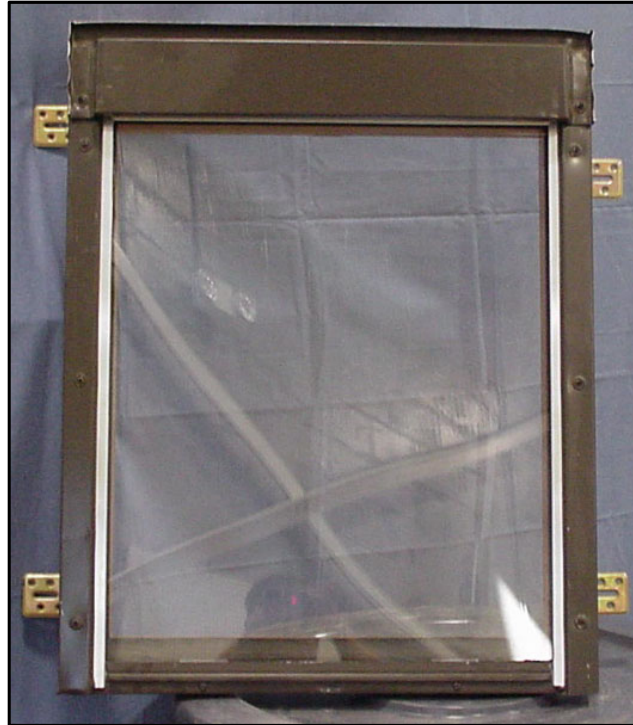
FSF M87**Mfg 03/1987 – 02/1995**

No replacement cladding parts.
Skylight replacement only with
fixed or venting skylight.
Distinguished by exterior screws
through the top of the cladding
covers

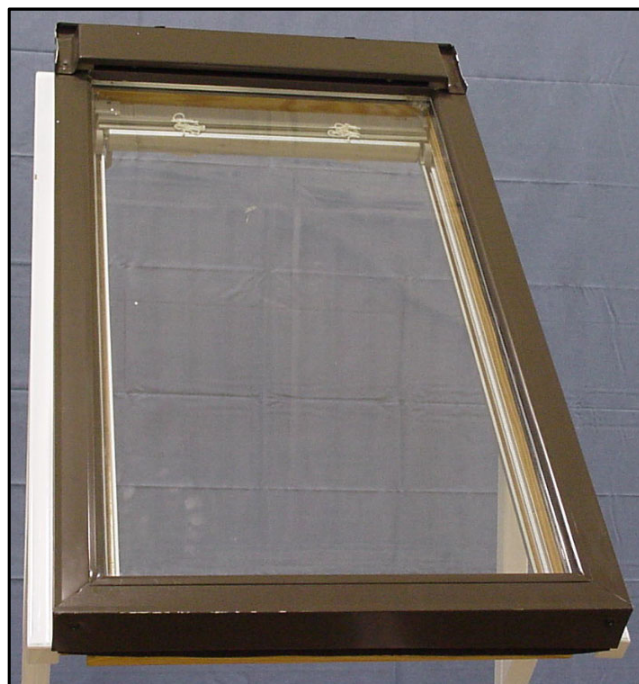
**FSF M95****Mfg 03/1995 – 07/2007**

Replacement cladding parts
available.

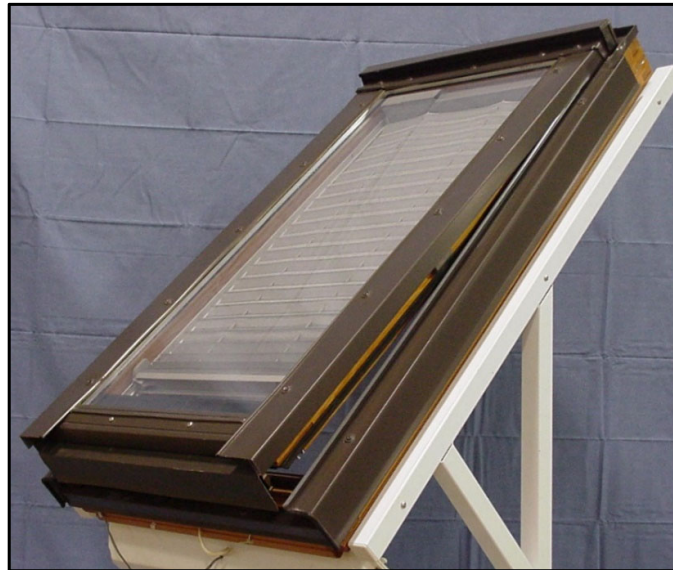
**VS M84 / VS M87 / VSC
Mfg 02/1983 – 01/1996**

No replacement cladding parts.
Skylight replacement only.
Distinguished by exterior screws
through the top of the cladding
covers

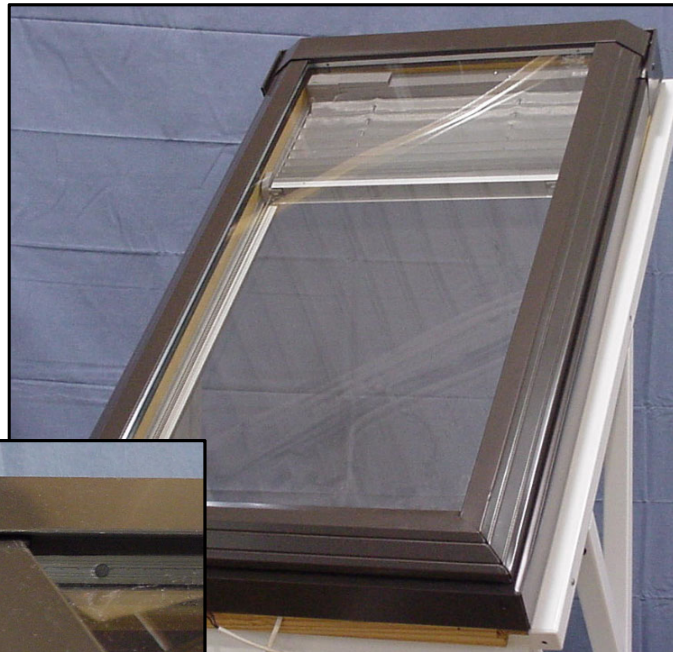
**VS M96 / VS M96B
Mfg 02/1996 – 02/1998**

No replacement cladding parts.
Skylight replacement only.
Distinguished by no exterior
screws in the side and bottom
claddings and shape of top
cladding cover.

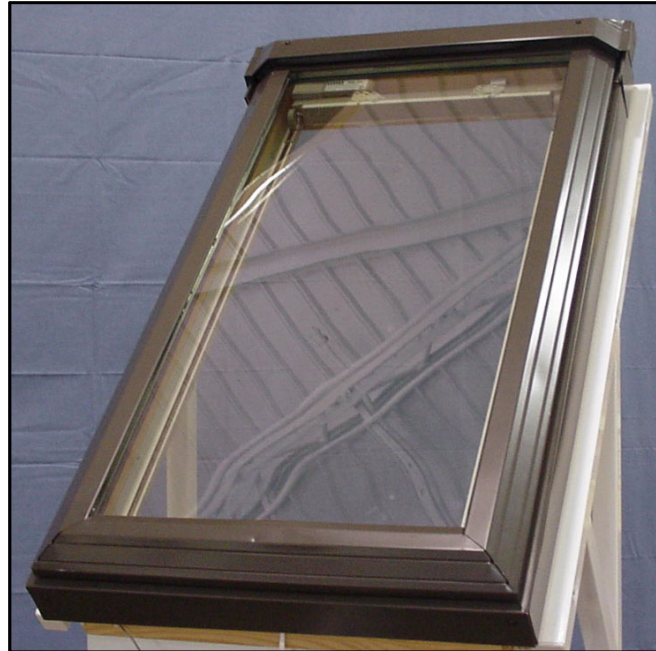
**VS M98 / VS M01 / VS M03
Mfg 04/1998 – 04/2004**

No replacement cladding parts.
Skylight replacement only.

VSE M01**Mfg 02/2000 – 04/2004**

Distinguished by shape of top
cladding cover.

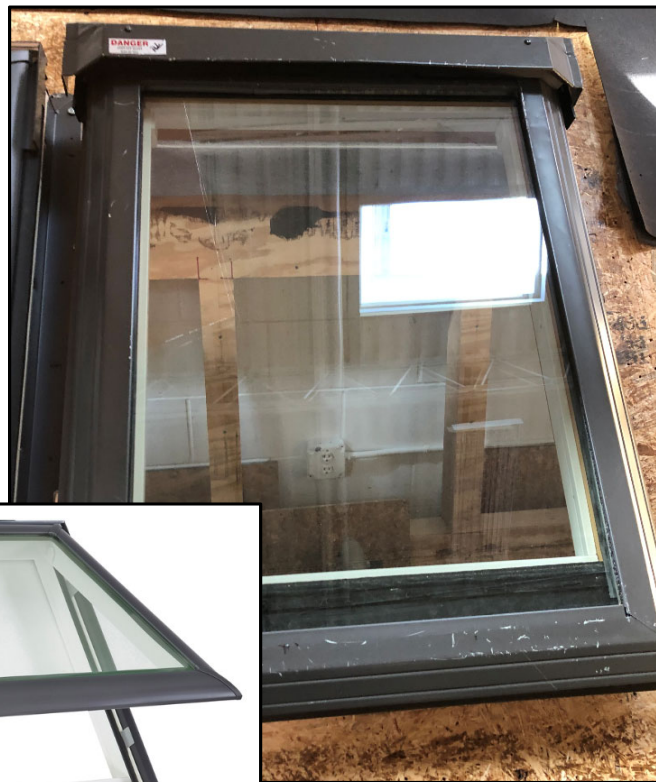
**VS / VSE H04****Mfg 05/2004 – 12/2009****VS / VSE / VSS A21****Mfg 01/2010 – Present**

Frame cladding parts available.
Sash complete required if sash
cladding damaged.

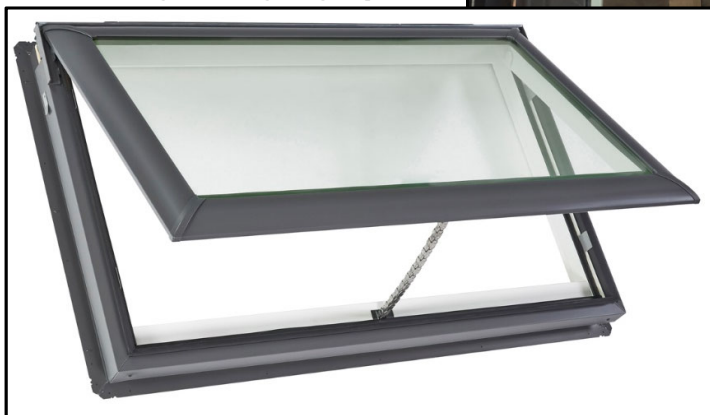
**A21 with rounded sash
cladding and light grey color**
