MAX RHOADS

CASE STUDY

THE REGIONAL WATER RESOURCE AGENCY

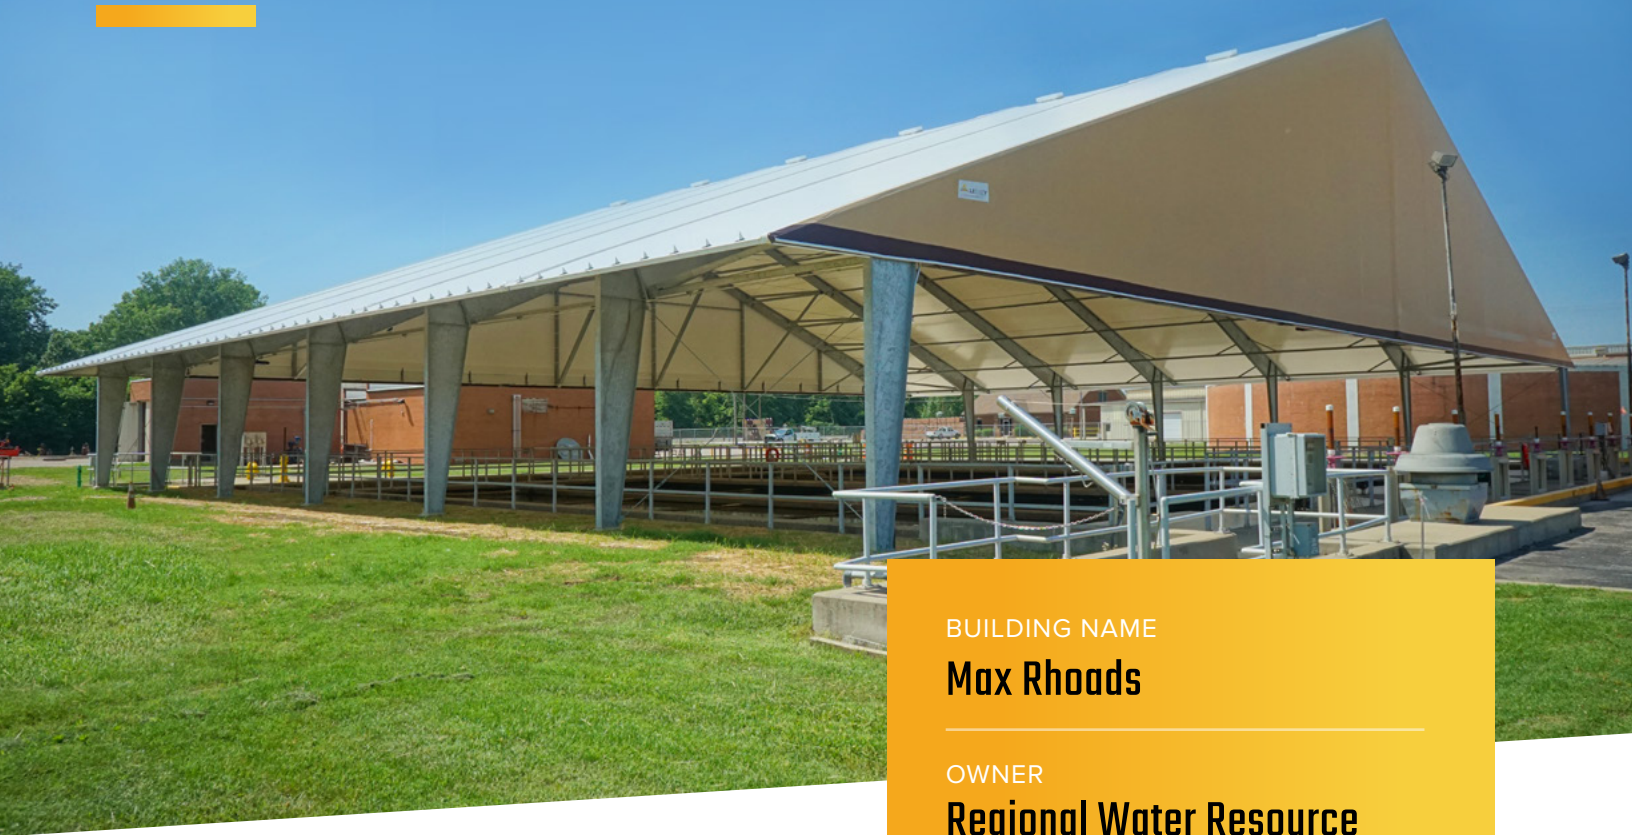
Legacy designed and installed a pavilion structure 136 feet wide by 112 feet long. The building has a covered roof and gable ends, along with four open walls. The cover keeps sunlight off the settling tanks, while the open walls allow a constant flow of fresh air in. Rooftop exhaust vents push warm, moist air out the top of the building, preventing moisture build-up and another source of corrosion.

Fabric has non-corrosive properties that extend the longevity of the structure when exposed to hydrogen sulfide. The solid steel frame and steel framing members are all hot dip galvanized to protect against corrosion. Rather than bracing cables that are vulnerable to corrosion, solid steel bracing rods withstand the rigors of daily use and exposure to corrosion.
