CASE STUDY

Friendship Equestrian Center

Riding Arena

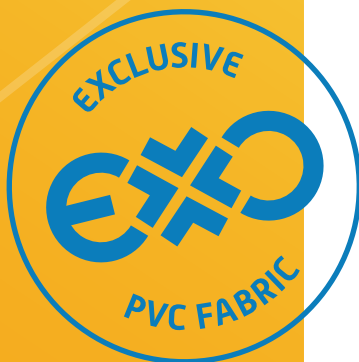
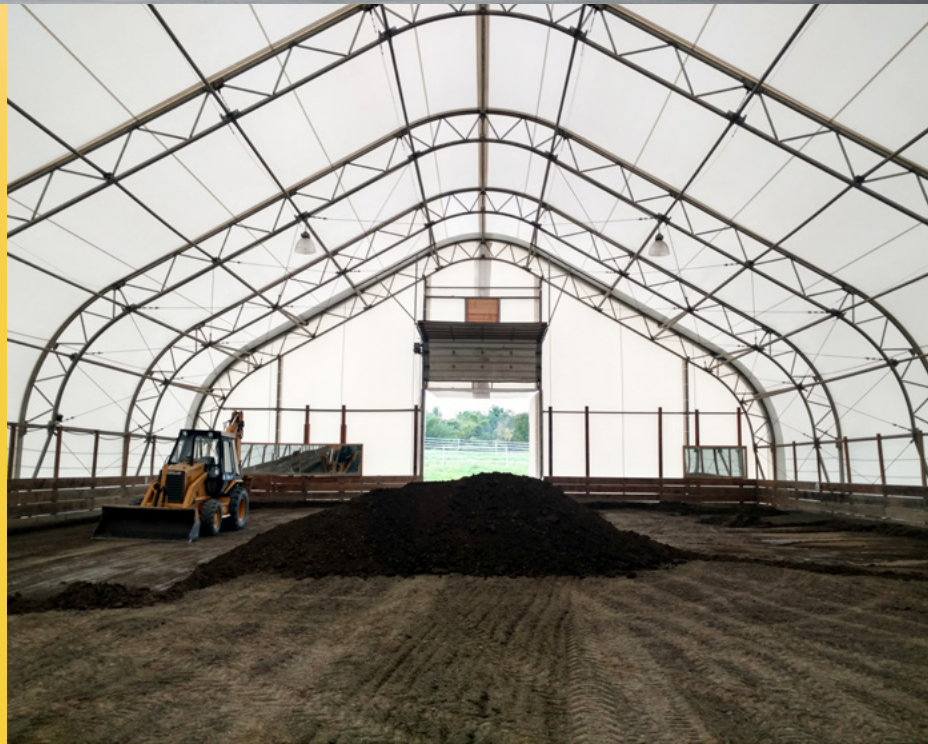
Finished recover by Legacy (above).

Legacy committed to replacing the cover without interrupting operations at FEC. New fabric panels were manufactured at Legacy’s headquarters based on measurements provided by FEC and the original building specifications. The majority of the building is white, with green trim along the edges of the building. When Legacy crews arrived on site, they removed the cover from the old building, disposed of the fabric and installed the new cover in about a week.

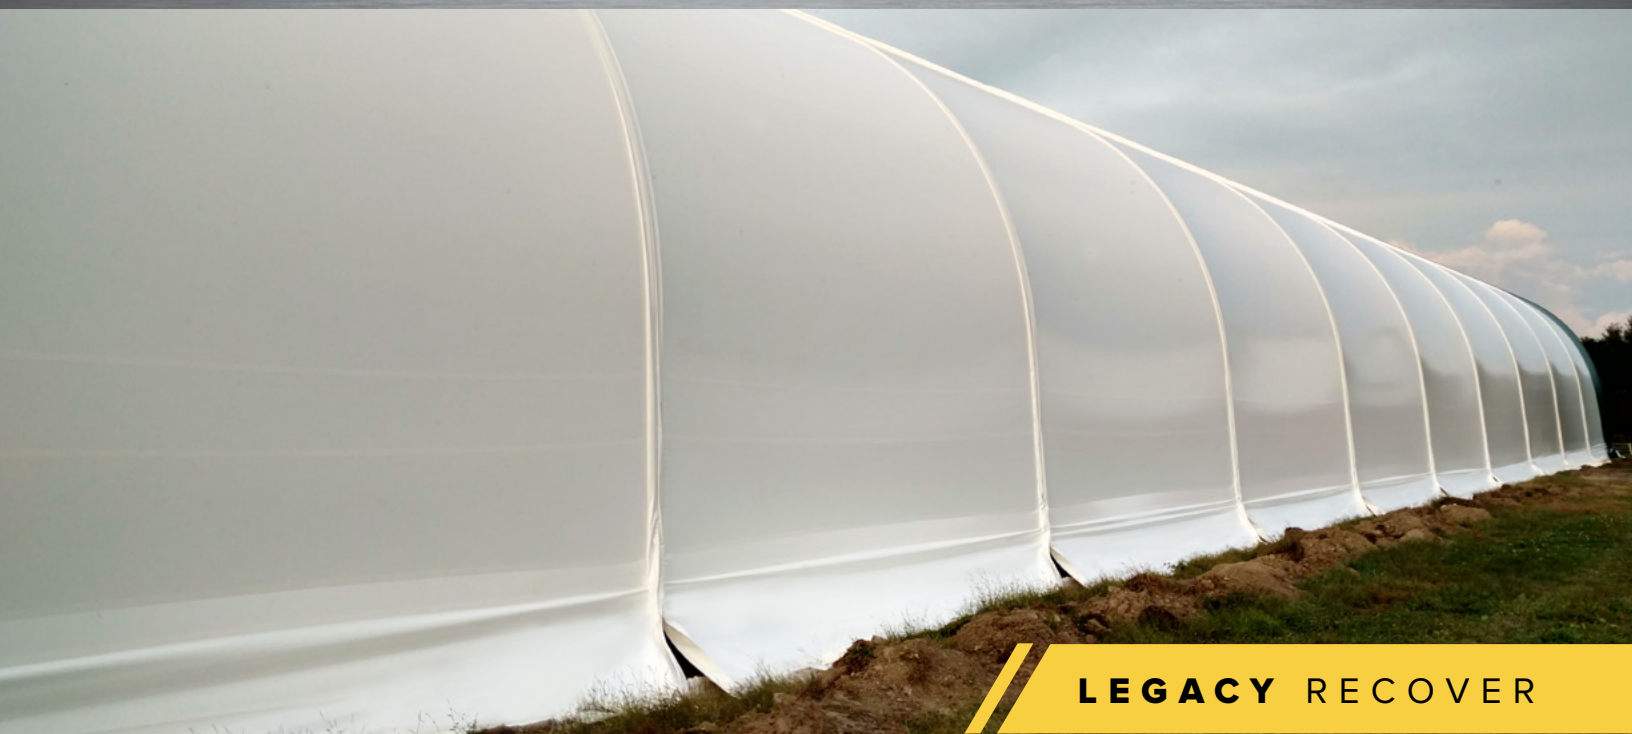
Original structure after Legacy completed the recover.
